## General Information

| Make | Toyota | Model | Vios |
| Registration No. | NHJ4855 | Chassis No. | PA1B18F30P4215374 |

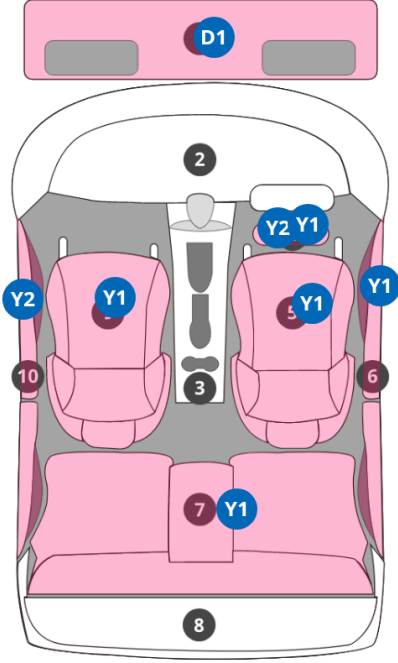
| Interior Evaluation : <b>A</b> | Exterior Evaluation : <b>C</b> |
| <p><b>Remarks</b><br/>(L) Front Floor Mat - Grime - Small / (R) Front Floor Mat - Grime - Minimal / (R) Front Seat - Grime - Minimal / (L) Front Seat - Grime - Minimal / Rear Seat - Grime - Minimal / (L) Front Trim - Grime - Small / (R) Front Trim - Grime - Minimal / Ceiling - Crinkle - Minimal</p> | <p><b>Remarks</b><br/>(R) Front Fender - Repair Traces - Yes / Bonnet - Repair Traces - Yes / (L) Front Fender - Repair Traces - Yes / Bonnet, Headlight - Scratch &amp; Dent - Minimal / (L) Front Fender, Molding - Scratch &amp; Dent - Minimal / (L) Front Door, Molding - Scratch &amp; Dent - Small / (L) Rear Door, Molding - Scratch - Medium / (L) Rear Fender, Molding - Scratch &amp; Dent - Minimal / Trunk Hood, Rear Gate - Scratch &amp; Dent - Minimal / Rear Bumper, Lamps, Panels - Scratch - Small / (R) Rear Fender, Molding - Scratch &amp; Dent - Minimal / (R) Rear Door, Molding - Scratch &amp; Dent - Small / (R) Front Door, Molding - Scratch &amp; Dent - Small / (R) Step, In-panel, Side Spoiler - Scratch &amp; Dent - Small / Front Bumper, Grille, Lamps - Scratch - Small / Roof - Dent - Small / (R) Front Fender, Molding - Scratch - Small / (L) Step, In-panel, Side Spoiler - Scratch - Small</p> |

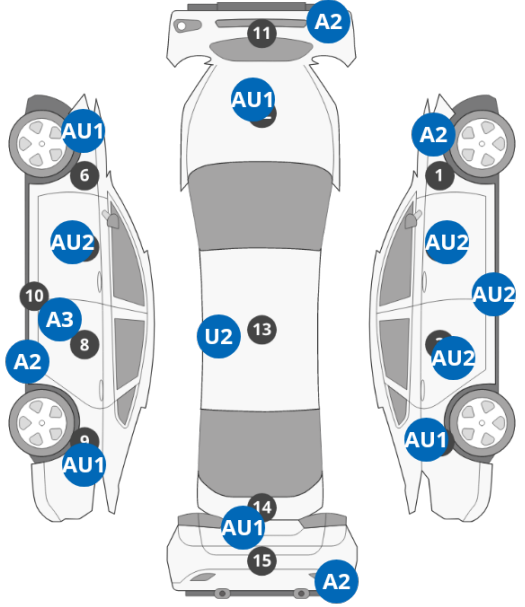
| Inspector Notes |
|---|
| <p>with LTO plate, with spare tire and key, with manual and warranty booklet, no tools and jack, no reverse camera, minor scratches and dent on exterior, scratches in taillight and headlight lens, taillight crack issue.</p> |
