## General Information

| Make | Toyota | Model | Vios |
| Registration No. | NJC3696 | Chassis No. | PA1B18F34S4287560 |

## Body / Panel Condition

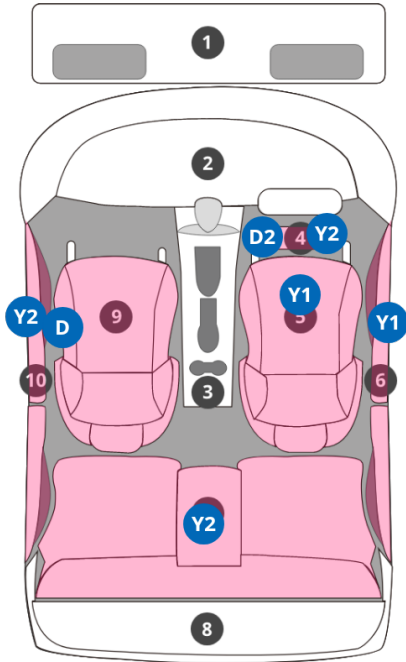
| Interior Evaluation : <b>B</b> | Exterior Evaluation : <b>E</b> |
| <p><b>Remarks</b><br/>Rear Seat - Grime - Small / (R) Front Trim - Grime - Minimal / (R) Front Seat - Grime - Minimal / (R) Front Floor Mat - Grime - Small / (L) Front Trim - Grime - Small / (L) Front Seat - Worn - Yes / (L) Front Floor Mat - Worked - Small</p> | <p><b>Remarks</b><br/>(L) Front Door, Molding - Scratch &amp; Dent - Large / (L) Step, In-panel, Side Spoiler - Scratch &amp; Dent - Medium / (L) Front Fender, Molding - Scratch - Small / (L) Rear Door, Molding - Scratch - Medium / (L) Rear Fender, Molding - Scratch - Small / Trunk Hood, Rear Gate - Scratch - Minimal / Rear Bumper, Lamps, Panels - Scratch - Small / (R) Rear Fender, Molding - Scratch - Small / (R) Rear Door, Molding - Scratch - Small / (R) Step, In-panel, Side Spoiler - Scratch - Small / (R) Front Door, Molding - Scratch - Small / (R) Front Fender, Molding - Scratch - Minimal / Bonnet, Headlight - Scratch - Small / Front Bumper, Grille, Lamps - Scratch - Medium / Roof - Scratch - Small</p> |

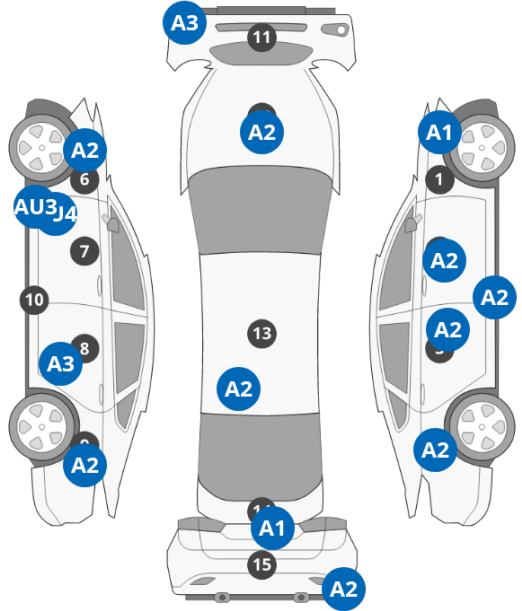
| Inspector Notes |
|---|
| with LTO plate/with warranty booklet/with incomplete tools with jack/with spare tire/no spare key/with seat cover/hairline scratches on the body/ |
