## General Information

| Make | Toyota | Model | Vios |
| YOM | 2024 | Odo Meter Reading | 43,966 |
| Registration No. | NHH7160 | Chassis No. | PA1B18F36R4250374 |

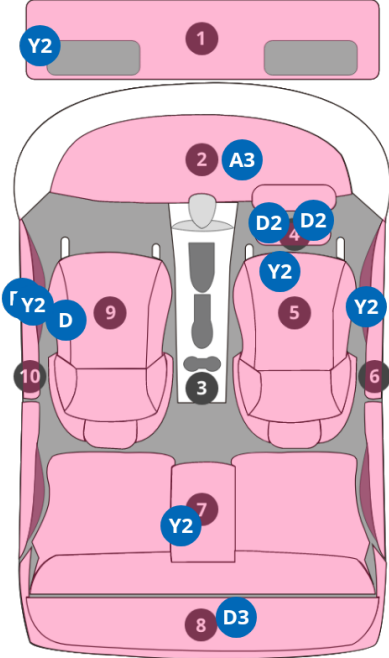
| Interior Evaluation : <span style="color: red; font-weight: bold;">C</span> | | Exterior Evaluation : <span style="color: red; font-weight: bold;">E</span> | |
|---|--|---|--|
| <p><b>Remarks</b></p> <p>Trunk Room - Loose, Deformed - Medium / (L) Front Seat - Worn - Yes / (R) Front Seat - Grime - Small / (R) Front Floor Mat - Worked - Small / (L) Front Floor Mat - Worked - Small / (L) Front Trim - Worked - Small / (R) Front Trim - Grime - Small / (L) Front Trim - Grime - Small / Dashboard - Worn, Scratch, Cut, Crack - Medium / Ceiling - Grime - Small / Rear Seat - Grime - Small</p> | | <p><b>Remarks</b></p> <p>(R) Front Fender, Molding - Scratch - Small / (R) Front Fender, Molding - Repair mark - Yes / (R) Mirror - Scratch - Minimal / (R) Front Door, Molding - Scratch &amp; Dent - Medium / (R) Rear Door, Molding - Scratch - Small / (R) Rear Fender, Molding - Scratch - Medium / (R) Step, In-panel, Side Spoiler - Scratch &amp; Dent - Small / Rear Bumper, Lamps, Panels - Scratch - Medium / Trunk Hood, Rear Gate - Dent - Medium / (L) Rear Fender, Molding - Scratch &amp; Dent - Medium / (L) Rear Door, Molding - Scratch &amp; Dent - Medium / (L) Front Door, Molding - Scratch &amp; Dent - Large / (L) Mirror - Scratch - Small / (L) Step, In-panel, Side Spoiler - Scratch &amp; Dent - Medium / (L) Front Fender, Molding - Scratch &amp; Dent - Large / Member (Bolted) - Dent - Yes / (L) Front Fender, Molding - Repair mark - Yes / Front Bumper, Grille, Lamps - Crack, Gap - Large / Bonnet, Headlight - Scratch - Small / (L) Rear Door, Molding - Repair mark - Yes / Roof - Repair mark - Yes / Roof - Scratch - Minimal / Front Bumper, Grille, Lamps - Repair mark - Yes</p> | |

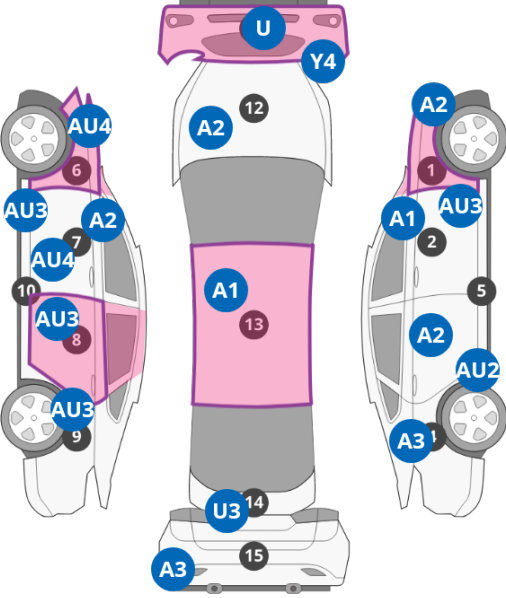
with warranty booklet and jack, incomplete tools, with spare tire, with LTO plate, scratches on headlight and tail light, suncrack taillight, cracked headlight, front bumper partially missing, head unit issue
