## General Information

| Make | Toyota | Model | Vios |
| Registration No. | DBN3371 | Chassis No. | PA1B18F30P4231784 |

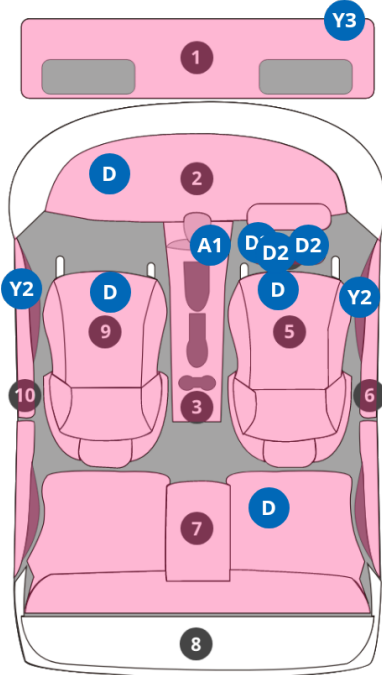
| Interior Evaluation : <b>C</b> | Exterior Evaluation : <b>D</b> |
| <b>Remarks</b><br>Dashboard - Traces of Adhesive Tape - Yes / (L) Front Floor Mat - Worked - Small / (R) Front Floor Mat - Worked - Small / (R) Front Seat - Worn - Yes / (L) Front Seat - Worn - Yes / Rear Seat - Worn - Yes / (L) Front Trim - Grime - Small / (R) Front Trim - Grime - Small / Ceiling - Grime - Medium / Mat Other - Worked - Small / Console, Switchs, Vents - Worn, Scratch, Cut, Crack - Minimal | <b>Remarks</b><br>(R) Front Fender - Repair Traces - Yes / (R) Front Fender, Molding - Repair mark - Difference in Color / (R) Front Fender, Molding - Scratch - Minimal / (R) Front Door, Molding - Dent - Medium / (R) Step, In-panel, Side Spoiler - Dent - Small / (R) Rear Door, Molding - Scratch - Minimal / (R) Rear Fender, Molding - Scratch - Minimal / Rear Bumper, Lamps, Panels - Scratch & Dent - Medium / Trunk Hood, Rear Gate - Scratch - Small / (L) Rear Fender, Molding - Scratch - Minimal / (L) Rear Door, Molding - Scratch - Medium / (L) Step, In-panel, Side Spoiler - Scratch - Small / (L) Front Door, Molding - Scratch - Minimal / (L) Front Fender, Molding - Scratch - Minimal / Front Bumper, Grille, Lamps - Scratch - Large / Bonnet, Headlight - Scratch - Minimal / Roof - Dent - Small |

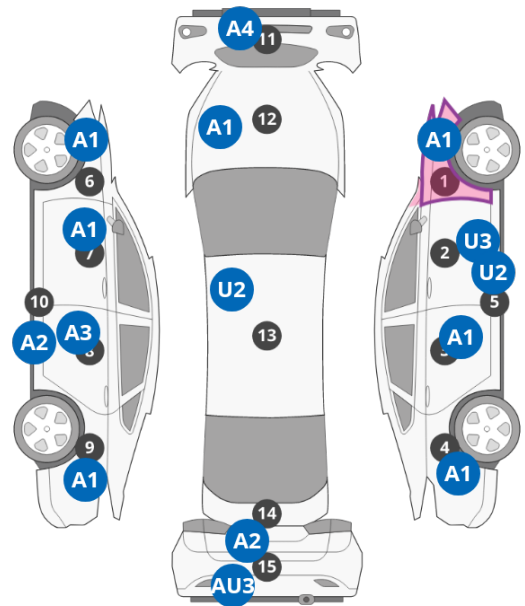
| Inspector Notes |
|---|
| with Ito plate/with spare tire/with tools no jack/with leather seat cover/with dent and scratches on the body/without spare key/without reverse camera |
