## General Information

| Make | Toyota | Model | Vios |
| YOM | 2024 | Odo Meter Reading | 33,926 |
| Registration No. | DBM2193 | Chassis No. | PA1B18F38R4242227 |

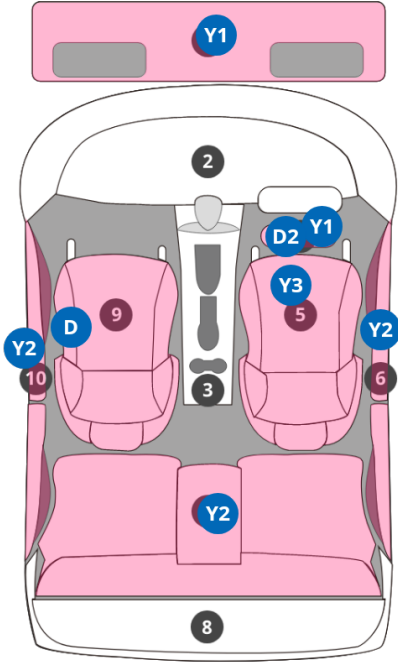
| Interior Evaluation : <b>B</b> | Exterior Evaluation : <b>E</b> |
| <p><b>Remarks</b></p> <p>Rear Seat - Grime - Small / (R) Front Trim - Grime - Small / (R) Front Seat - Grime - Medium / (R) Front Floor Mat - Grime - Minimal / (L) Front Trim - Grime - Small / (L) Front Seat - Worn - Yes / (L) Front Floor Mat - Worked - Small / Ceiling - Grime - Minimal</p> | <p><b>Remarks</b></p> <p>(L) Front Fender - Repair Traces - Yes / (L) Front Door - Repair Traces - Yes / (L) Rear Door - Repair Traces - Yes / (L) Front Fender, Molding - Repair mark - Yes / (L) Front Door, Molding - Repair mark - Yes / (L) Rear Door, Molding - Repair mark - Yes / (L) Front Fender, Molding - Scratch - Minimal / (L) Front Door, Molding - Scratch &amp; Dent - Small / (L) Step, In-panel, Side Spoiler - Scratch - Small / (L) Rear Door, Molding - Scratch - Small / (L) Rear Fender, Molding - Scratch &amp; Dent - Small / Rear Bumper, Lamps, Panels - Scratch &amp; Dent - Medium / Trunk Hood, Rear Gate - Scratch - Small / (R) Rear Fender, Molding - Scratch - Minimal / (R) Step, In-panel, Side Spoiler - Scratch - Medium / (R) Front Door, Molding - Scratch &amp; Dent - Large / (R) Rear Door, Molding - Scratch - Minimal / (R) Front Fender, Molding - Scratch - Small / Front Bumper, Grille, Lamps - Scratch - Large / Bonnet, Headlight - Scratch - Small / Roof - Scratch - Small</p> |
