## General Information

| Make | Toyota | Model | Vios |
| YOM | 2023 | Odo Meter Reading | 147,198 |
| Registration No. | NHI8811 | Chassis No. | PA1B18F30P4209011 |

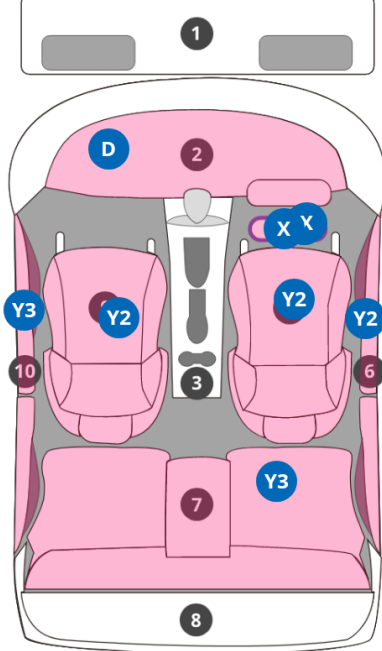
| Interior Evaluation : <b>B</b> | Exterior Evaluation : <b>E</b> |
|---|---|
| <p><b>a</b> : Cut, Fray <b>d</b> : Loose, Deformed <b>k</b> : Animal Hair <b>s</b> : Smell <b>t</b> : Cigarette Burns <b>x</b> : Defective <b>y</b> : Stain</p> | <p><b>A</b> : Scratch <b>AU</b> : Scratch &amp; Dent <b>B</b> : Modified <b>C</b> : Corrosion <b>G</b> : Stone chip <b>P</b> : Faded <b>S</b> : Rust <b>SC</b> : Rust &amp; Corrosion <b>U</b> : Dent <b>X</b> : Defective <b>Y</b> : Crack, Gap</p> |
| <p><b>Remarks</b></p> <p>(L) Front Floor Mat - Missing - Yes / (R) Front Floor Mat - Missing - Yes / Mat Other - Missing - Yes / (L) Front Seat - Grime - Small / (R) Front Seat - Grime - Small / Rear Seat - Grime - Medium / (L) Front Trim - Grime - Medium / (R) Front Trim - Grime - Small / Dashboard - Traces of Adhesive Tape - Yes</p> | <p><b>Remarks</b></p> <p>(R) Front Door - Repair Traces - Yes / (R) Step - Repair Traces - Yes / (R) Front Fender - Repair Traces - Yes / Bonnet - Repair Traces - Yes / (L) Front Fender - Repair Traces - Yes / (R) Front Door, Molding - Scratch &amp; Dent - Medium / (R) Front Door, Molding - Repair mark - Yes / (R) Front Fender, Molding - Repair mark - Yes / (R) Front Fender, Molding - Scratch - Small / Bonnet, Headlight - Repair mark - Yes / Bonnet, Headlight - Scratch &amp; Dent - Small / (L) Front Fender, Molding - Scratch - Small / Front Bumper, Grille, Lamps - Scratch - Medium / (L) Front Door, Molding - Scratch &amp; Dent - Small / (L) Rear Door, Molding - Modified - Minimal / (L) Rear Fender, Molding - Scratch &amp; Dent - Small / Rear Bumper, Lamps, Panels - Repair mark - Yes / Trunk Hood, Rear Gate - Scratch &amp; Dent - Small / Rear Bumper, Lamps, Panels - Scratch - Small / (R) Rear Fender, Molding - Scratch &amp; Dent - Small / (R) Rear Door, Molding - Scratch - Small / (R) Step, In-panel, Side Spoiler - Scratch &amp; Dent - Minimal / Roof - Dent - Small</p> |

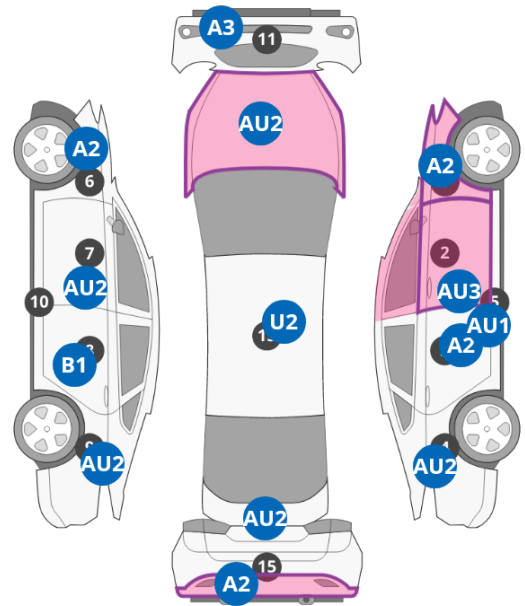
| Inspector Notes |
|---|
| <p>with LTO plate,with warranty and manual booklet, with jack, no reverse camera ,no spare key, scratches and dent on exterior,scratches in taillight and headlight, issue rear taillight.</p> |
