## General Information

| Make | Toyota | Model | Vios |
| Registration No. | DBI4069 | Chassis No. | PA1B18F32P4215148 |

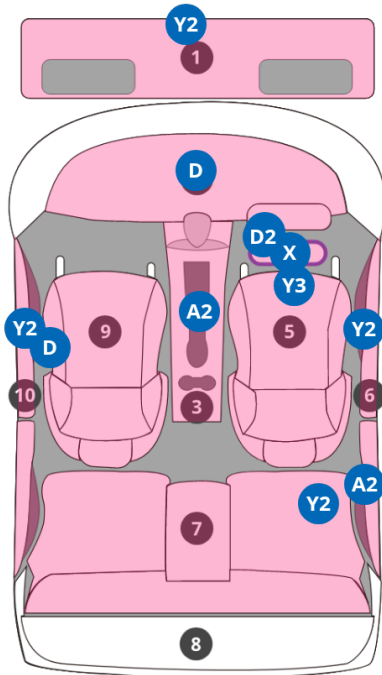
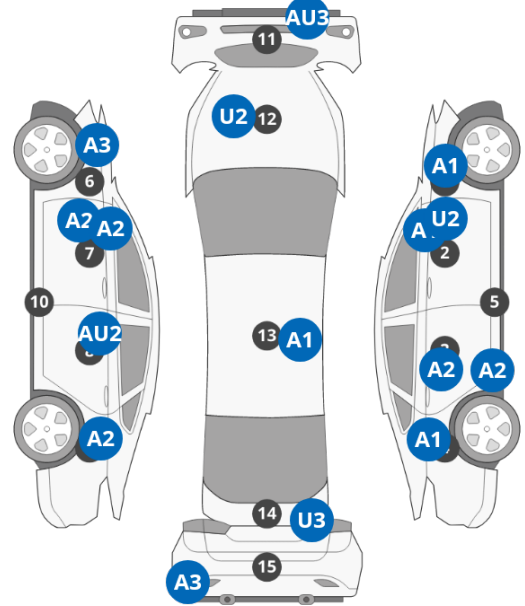
| Interior Evaluation : <b>C</b> | Exterior Evaluation : <b>D</b> |
| <p><b>Remarks</b></p> <p>Mat Other - Missing - Yes / (L) Front Floor Mat - Cut, Crack - Small / (L) Front Floor Mat - Worked - Small / (L) Front Seat - Worn - Yes / (R) Front Seat - Grime - Medium / (L) Front Trim - Grime - Small / (R) Front Trim - Grime - Small / Console, Switches, Vents - Worn, Scratch, Cut, Crack - Small / Ceiling - Grime - Small / Dashboard - Traces of Adhesive Tape - Yes / Rear Seat - Grime - Small / (R) Rear Trim - Cut, Crack - Small</p> | <p><b>Remarks</b></p> <p>(R) Mirror - Scratch - Minimal / (R) Front Fender, Molding - Scratch - Minimal / (R) Front Door, Molding - Dent - Small / (R) Step, In-panel, Side Spoiler - Scratch - Small / (R) Rear Door, Molding - Scratch - Small / (R) Rear Fender, Molding - Scratch - Minimal / Trunk Hood, Rear Gate - Dent - Medium / Rear Bumper, Lamps, Panels - Scratch - Medium / (L) Rear Fender, Molding - Scratch - Small / (L) Front Door, Molding - Scratch - Small / (L) Front Fender, Molding - Scratch - Medium / (L) Mirror - Scratch - Small / Front Bumper, Grille, Lamps - Scratch &amp; Dent - Medium / Bonnet, Headlight - Dent - Small / Roof - Scratch - Minimal / (L) Rear Door, Molding - Scratch &amp; Dent - Small</p> |
