## General Information

| Make | Toyota | Model | Vios |
| Registration No. | NKD7564 | Chassis No. | PA1B18F33R4259033 |

## Body / Panel Condition

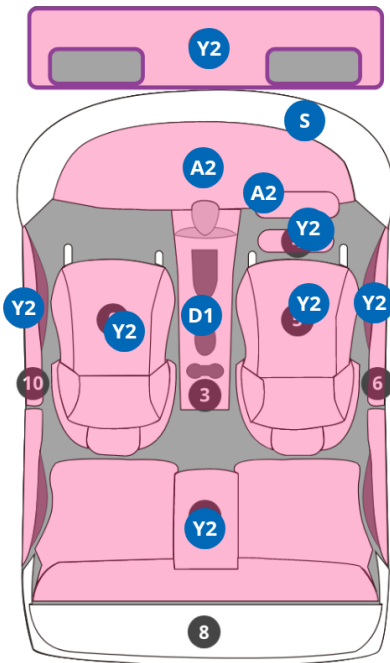
| Interior Evaluation : <b>C</b> | Exterior Evaluation : <b>E</b> |
|---|---|
| <p><b>a</b> : Cut, Fray <b>d</b> : Loose, Deformed <b>k</b> : Animal Hair <b>s</b> : Smell <b>t</b> : Cigarette Burns <b>x</b> : Defective <b>y</b> : Stain</p> | <p><b>A</b> : Scratch <b>AU</b> : Scratch &amp; Dent <b>B</b> : Modified <b>C</b> : Corrosion <b>G</b> : Stone chip <b>P</b> : Faded <b>S</b> : Rust <b>SC</b> : Rust &amp; Corrosion <b>U</b> : Dent <b>X</b> : Defective <b>Y</b> : Crack, Gap</p> |
| <p><b>Remarks</b></p> <p>(R) Front Seat - Grime - Small / (L) Front Seat - Grime - Small / Rear Seat - Grime - Small / (L) Front Trim - Grime - Small / (R) Front Trim - Grime - Small / Console, Switchs, Vents - Worked - Minimal / Room Lamp - Missing - Yes / Ceiling - Grime - Small / Glove Box - Worn, Scratch, Cut, Crack - Small / (L) Front Floor Mat - Grime - Small / (R) Front Floor Mat - Grime - Small / Mat Other - Grime - Small / Overall Interior - Smell - Yes / Steering Wheel - Worn, Peel, Crack - Small</p> | <p><b>Remarks</b></p> <p>(R) Front Fender - Repair Traces - Yes / Bonnet - Repair Traces - Yes / (L) Front Fender - Repair Traces - Yes / (L) Rear Door - Repair Traces - Yes / (L) Rear Fender - Repair Traces - Yes / Trunk Hood, Rear Gate - Repair Traces - Yes / Rear End Panel - Repair Traces - Yes / (R) Rear Door - Repair Traces - Yes / Roof - Scratch &amp; Dent - Small / (R) Rear Fender, Molding - Repair mark - Yes / (R) Rear Fender, Molding - Modified - Minimal / (R) Rear Door, Molding - Scratch &amp; Dent - Small / (R) Front Door, Molding - Scratch &amp; Dent - Small / (R) Front Fender, Molding - Scratch &amp; Dent - Minimal / Bonnet, Headlight - Scratch &amp; Dent - Minimal / Front Bumper, Grille, Lamps - Scratch - Medium / (L) Front Fender, Molding - Scratch &amp; Dent - Small / (L) Front Door, Molding - Scratch - Large / (L) Rear Door, Molding - Repair mark - Yes / (L) Rear Door, Molding - Scratch &amp; Dent - Minimal / (L) Rear Fender, Molding - Repair mark - Yes / Trunk Hood, Rear Gate - Repair mark - Yes / Rear Bumper, Lamps, Panels - Repair mark - Yes / Trunk Hood, Rear Gate - Scratch &amp; Dent - Minimal / Rear Bumper, Lamps, Panels - Scratch - Medium / (L) Step, In-panel, Side Spoiler - Repair mark - Yes / (L) Step, In-panel, Side Spoiler - Scratch - Small / (R) Step, In-panel, Side Spoiler - Repair mark - Yes</p> |

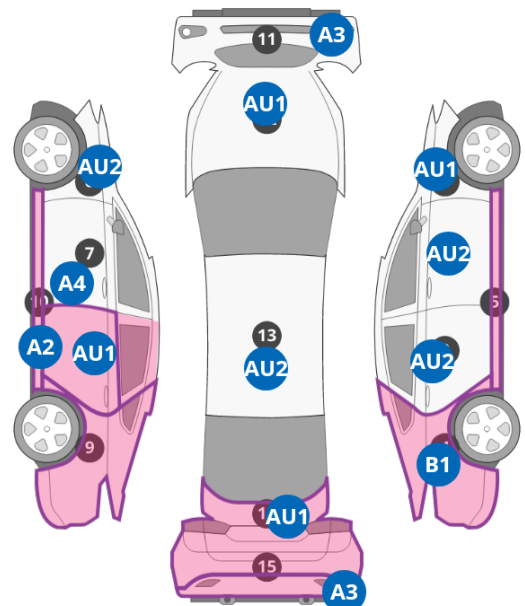
| Inspector Notes |
|---|
| with LTO plate, with spare tire, with warranty and manual booklet, with jack and inc tools, with reverse camera, no spare key, scratches and dent on exterior, scratches in taillight and headlight, issue in map light button, |
