## General Information

| Make | Toyota | Model | Vios |
| YOM | 2025 | Odo Meter Reading | 30,106 |
| Registration No. | NJC8611 | Chassis No. | PA1B18F31S4288830 |

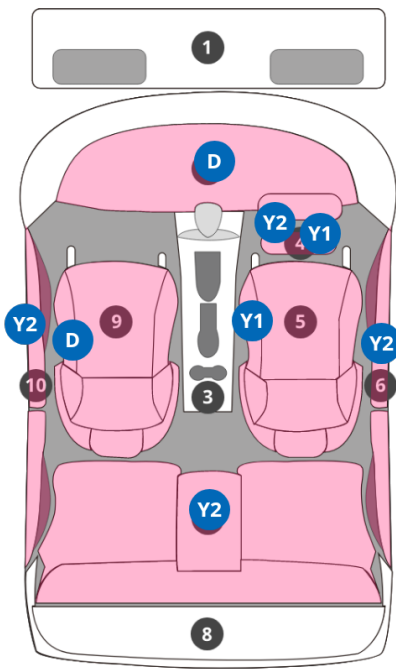
| <div> <div>Interior Evaluation :</div> <div>B</div> </div> | <div> <div>Exterior Evaluation :</div> <div>C</div> </div> |
| <div> <div>Remarks</div> <div>Rear Seat - Grime - Small / (R) Front Trim - Grime - Small / (R) Front Floor Mat - Grime - Minimal / (R) Front Seat - Grime - Minimal / (L) Front Seat - Worn - Yes / (L) Front Trim - Grime - Small / (L) Front Floor Mat - Grime - Small / Dashboard - Traces of Adhesive Tape - Yes</div> </div> | <div> <div>Remarks</div> <div>(L) Front Fender - Repair Traces - Yes / (L) Front Fender, Molding - Repair mark - Yes / (L) Front Fender, Molding - Scratch - Minimal / Bonnet, Headlight - Scratch &amp; Dent - Minimal / Front Bumper, Grille, Lamps - Repair mark - Yes / Front Bumper, Grille, Lamps - Scratch - Small / (L) Step, In-panel, Side Spoiler - Scratch - Small / (L) Front Door, Molding - Scratch - Minimal / (L) Rear Door, Molding - Scratch - Small / (L) Rear Fender, Molding - Scratch - Minimal / Rear Bumper, Lamps, Panels - Scratch - Medium / Trunk Hood, Rear Gate - Scratch - Minimal / (R) Rear Fender, Molding - Scratch - Small / (R) Step, In-panel, Side Spoiler - Scratch - Small / (R) Rear Door, Molding - Scratch - Minimal / (R) Front Door, Molding - Scratch - Small / (R) Mirror - Scratch - Minimal / (R) Front Fender, Molding - Scratch - Small / Roof - Scratch - Minimal</div> </div> |
