## General Information

| Make | Toyota | Model | Vios |
| Registration No. | DBM6746 | Chassis No. | PA1B18F30R4247132 |

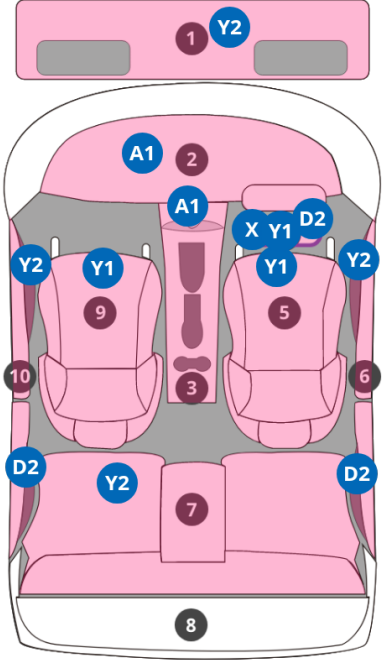
| Interior Evaluation : <b>B</b> | Exterior Evaluation : <b>C</b> |
| <p><b>Remarks</b></p> <p>(L) Front Floor Mat - Missing - Yes / (R) Front Floor Mat - Worked - Small / Dashboard - Worn, Scratch, Cut, Crack - Minimal / (R) Front Seat - Grime - Minimal / (L) Front Seat - Grime - Minimal / (L) Front Trim - Grime - Small / (R) Front Trim - Grime - Small / Mat Other - Grime - Minimal / Rear Seat - Grime - Small / Ceiling - Grime - Small / Console, Switches, Vents - Worn, Scratch, Cut, Crack - Minimal / (L) Rear Trim - Worked - Small / (R) Rear Trim - Worked - Small</p> | <p><b>Remarks</b></p> <p>(R) Front Fender, Molding - Dent - Small / (R) Mirror - Crack - Damaged / (R) Front Door, Molding - Scratch - Minimal / (R) Step, In-panel, Side Spoiler - Scratch - Small / (R) Rear Door, Molding - Scratch - Minimal / (R) Rear Fender, Molding - Scratch - Minimal / Trunk Hood, Rear Gate - Scratch - Minimal / Rear Bumper, Lamps, Panels - Scratch - Minimal / (L) Rear Fender, Molding - Scratch - Minimal / (L) Step, In-panel, Side Spoiler - Scratch - Small / (L) Rear Door, Molding - Scratch - Minimal / (L) Front Door, Molding - Scratch - Minimal / (L) Front Fender, Molding - Scratch - Minimal / Front Bumper, Grille, Lamps - Scratch - Small / Bonnet, Headlight - Scratch - Minimal / Roof - Scratch - Minimal</p> |

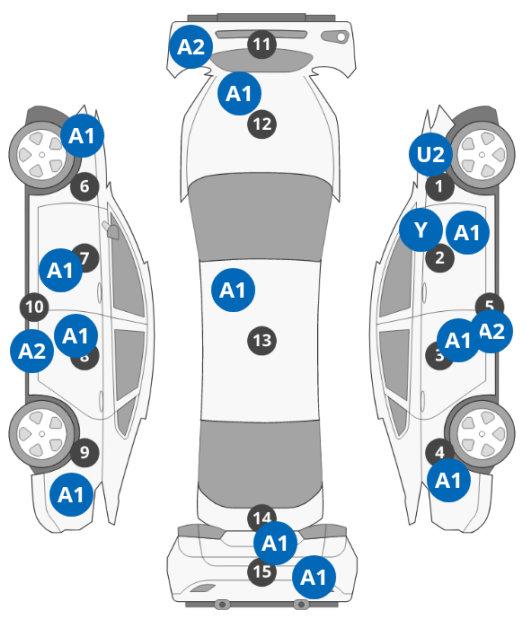
| Inspector Notes |
|---|
| <p>with Ito plate/without warrsnty booklet/with jack no tools/with dent and hairlines scratches on the body/with reverse camera/without spare key/with spare tire without mags</p> |
