## General Information

| Make | Toyota | Model | Hilux |
| YOM | 2022 | Mileage | 53,678 |
| Registration No. | CBD2695 | Chassis No. | MR0JB8DDSN3193403 |

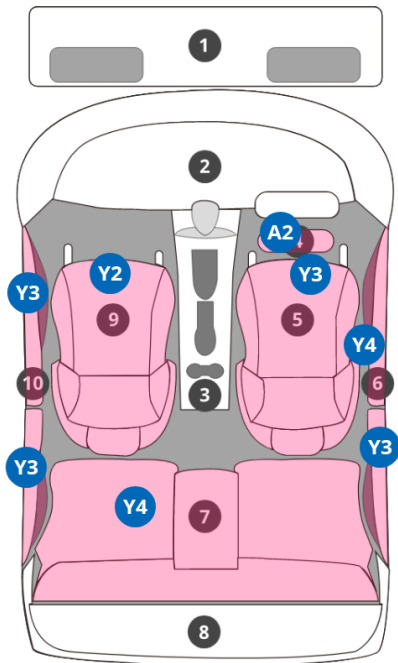
| Interior Evaluation : <b>D</b> | Exterior Evaluation : <b>D</b> |
| <b>Remarks</b><br>(R) Front Seat - Grime - Medium / (L) Front Seat - Grime - Small / Rear Seat - Grime - Large / (L) Front Floor Mat - Cut, Crack - Small / (R) Front Trim - Grime - Large / (R) Rear Trim - Grime - Medium / (L) Front Trim - Grime - Medium / (L) Rear Trim - Grime - Medium | <b>Remarks</b><br>Front Bumper, Grille, Lamps - Scratch & Dent - Large / Roof - Scratch - Large / (R) Side Gate - Scratch & Dent - Large / (R) Front Door, Molding - Scratch & Dent - Small / (L) Side Gate - Scratch - Large / Rear Gate - Dent - Small / Bonnet, Headlight - Dent - Small / Rear Bumper, Lamps, Panels - Scratch - Small |
