## General Information

| Make | Toyota | Model | Vios |
| Registration No. | DCD8544 | Chassis No. | PA1B18F39S4303767 |

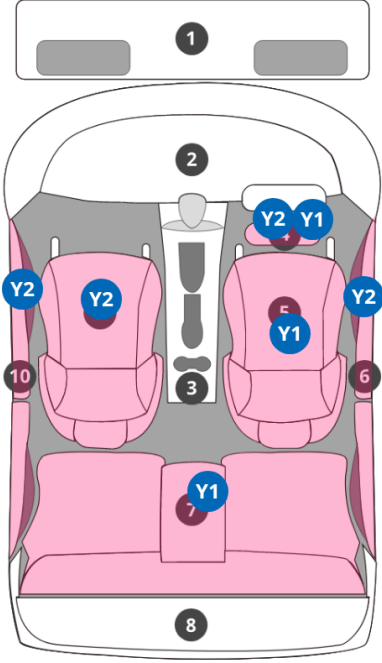
| Interior Evaluation : <b>B</b> | Exterior Evaluation : <b>D</b> |
|---|---|
| <p><b>Remarks</b><br/>(L) Front Seat - Grime - Small / (R) Front Seat - Grime - Minimal / (L) Front Floor Mat - Grime - Small / (R) Front Floor Mat - Grime - Minimal / Rear Seat - Grime - Minimal / (R) Front Trim - Grime - Small / (L) Front Trim - Grime - Small</p> | <p><b>Remarks</b><br/>(R) Front Fender - Repair Traces - Yes / Bonnet - Repair Traces - Yes / (L) Front Fender - Repair Traces - Yes / Roof - Scratch - Small / (L) Front Door, Molding - Scratch &amp; Dent - Small / (L) Rear Door, Molding - Scratch &amp; Dent - Minimal / (L) Rear Fender, Molding - Scratch &amp; Dent - Small / (L) Step, In-panel, Side Spoiler - Scratch - Small / (L) Front Fender, Molding - Scratch &amp; Dent - Small / Bonnet, Headlight - Scratch &amp; Dent - Small / Front Bumper, Grille, Lamps - Scratch - Medium / (R) Front Fender, Molding - Scratch &amp; Dent - Medium / (R) Step, In-panel, Side Spoiler - Scratch &amp; Dent - Small / (R) Front Door, Molding - Scratch &amp; Dent - Minimal / (R) Rear Door, Molding - Scratch &amp; Dent - Small / (R) Rear Fender, Molding - Dent - Small / Rear Bumper, Lamps, Panels - Scratch &amp; Dent - Small / Trunk Hood, Rear Gate - Scratch &amp; Dent - Small</p> |

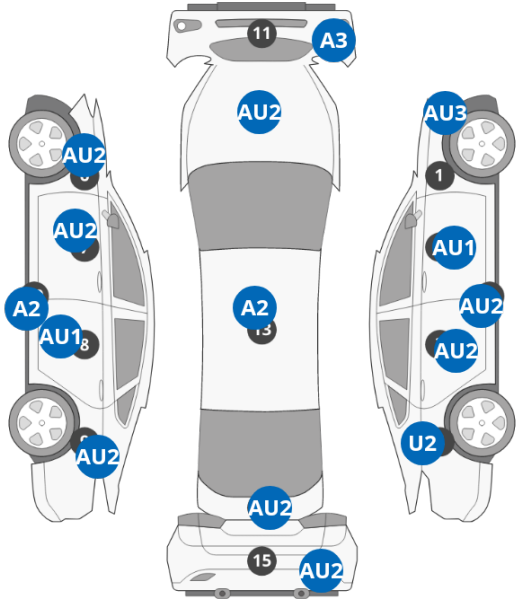
| Inspector Notes |
|---|
| <p>with LTO plate, with spare tire and key, with jack and inc tools,with manual and warranty booklet, with reverse camera,minor scratches and dent on exterior,scratches in taillight and headlight.</p> |
