## General Information

| Make | Toyota | Model | Vios |
| Registration No. | NHS9338 | Chassis No. | PA1B18F31R4268328 |

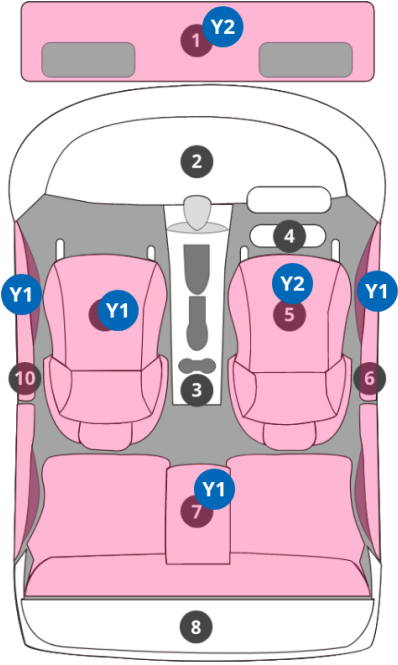
| <b>Remarks</b><br>(R) Front Seat - Grime - Small / (L) Front Trim - Grime - Minimal / (R) Front Trim - Grime - Minimal / Ceiling - Grime - Small / (L) Front Seat - Grime - Minimal / Rear Seat - Grime - Minimal | <b>Remarks</b><br>Roof - Scratch - Small / (L) Rear Door, Molding - Scratch & Dent - Small / (L) Step, In-panel, Side Spoiler - Scratch & Dent - Small / (L) Rear Fender, Molding - Scratch & Dent - Small / Trunk Hood, Rear Gate - Scratch - Small / (R) Rear Fender, Molding - Scratch & Dent - Minimal / Rear Bumper, Lamps, Panels - Scratch - Small / (R) Rear Door, Molding - Scratch & Dent - Minimal / (R) Step, In-panel, Side Spoiler - Scratch & Dent - Minimal / (R) Front Fender, Molding - Scratch & Dent - Minimal / Bonnet, Headlight - Scratch & Dent - Minimal / Front Bumper, Grille, Lamps - Scratch - Medium / (L) Front Fender, Molding - Scratch & Dent - Minimal / (L) Front Door, Molding - Scratch & Dent - Minimal / (R) Front Door, Molding - Scratch & Dent - Minimal |

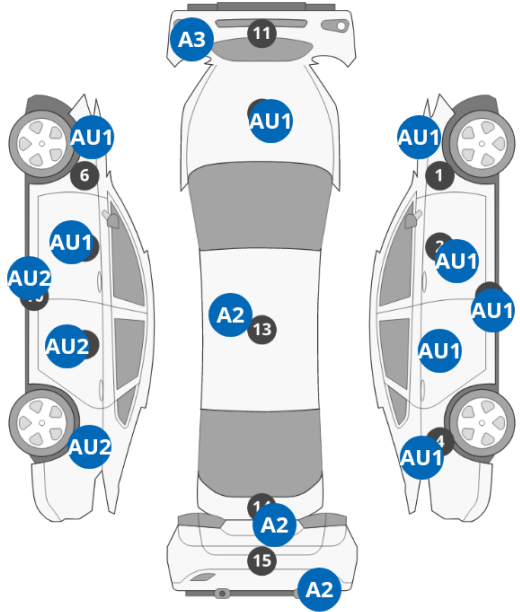
| Inspector Notes |
|---|
| with LTO plate, with spare tire, with reverse camera, with jack and inc tools, with manual booklet, no warranty, no spare key, scratches and dent on exterior, scratches in taillight and headlight, issue in trunk latch. |
