## General Information

| Make | Toyota | Model | Avanza |

## Body / Panel Condition

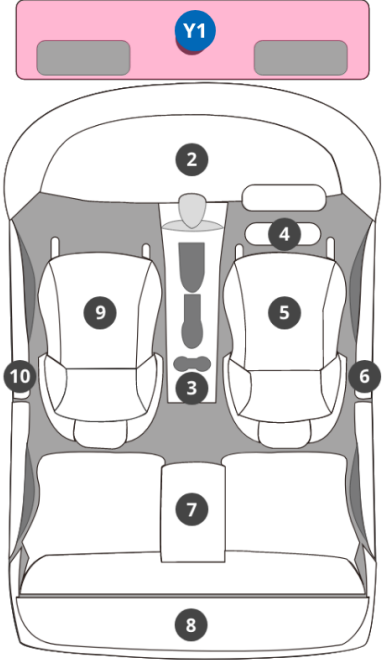
| Interior Evaluation : <b>A</b> | Exterior Evaluation : <b>B</b> |
| <b>Remarks</b><br>Ceiling - Grime - Minimal | <b>Remarks</b><br>(R) Front Fender, Molding - Scratch - Minimal / (R) Front Door, Molding - Scratch - Small / (R) Step, In-panel, Side Spoiler - Scratch - Minimal / (R) Rear Door, Molding - Scratch - Minimal / (R) Rear Fender, Molding - Scratch - Minimal / Rear Bumper, Lamps, Panels - Scratch - Minimal / Trunk Hood, Rear Gate - Scratch - Minimal / (L) Rear Fender, Molding - Scratch - Small / (L) Rear Door, Molding - Scratch - Minimal / (L) Front Door, Molding - Scratch - Minimal / (L) Step, In-panel, Side Spoiler - Scratch - Minimal / (L) Front Fender, Molding - Scratch - Minimal / Bonnet, Headlight - Scratch - Small / Front Bumper, Grille, Lamps - Scratch - Medium |
