## General Information

| Make | Toyota | Model | Wigo |
| Registration No. | NEN9090 | Chassis No. | MHKAA1BC2SJ040405 |

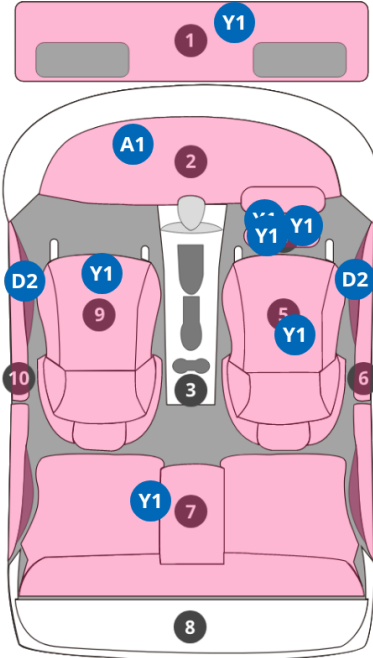
| Interior Evaluation : | | Exterior Evaluation : | |
|---|--|---|--|
| <p><b>Remarks</b></p> <p>(R) Front Floor Mat - Grime - Minimal / (L) Front Floor Mat - Grime - Minimal / (R) Front Seat - Grime - Minimal / (L) Front Seat - Grime - Minimal / Rear Seat - Grime - Minimal / Ceiling - Grime - Minimal / Dashboard - Worn, Scratch, Cut, Crack - Minimal / (L) Front Trim - Worked - Small / (R) Front Trim - Worked - Small / Mat Other - Grime - Minimal</p> | | <p><b>Remarks</b></p> <p>(R) Front Fender, Molding - Scratch - Minimal / (R) Step, In-panel, Side Spoiler - Scratch - Small / (R) Front Door, Molding - Scratch - Minimal / (R) Rear Door, Molding - Scratch - Medium / (R) Rear Fender, Molding - Scratch - Small / Trunk Hood, Rear Gate - Scratch - Minimal / (L) Rear Fender, Molding - Scratch - Medium / (L) Rear Door, Molding - Scratch - Small / (L) Front Door, Molding - Scratch - Small / (L) Front Fender, Molding - Scratch - Minimal / (L) Step, In-panel, Side Spoiler - Scratch - Small / Bonnet, Headlight - Scratch - Small / Roof - Scratch - Small / Rear Bumper, Lamps, Panels - Scratch - Small / Front Bumper, Grille, Lamps - Scratch - Medium</p> | |

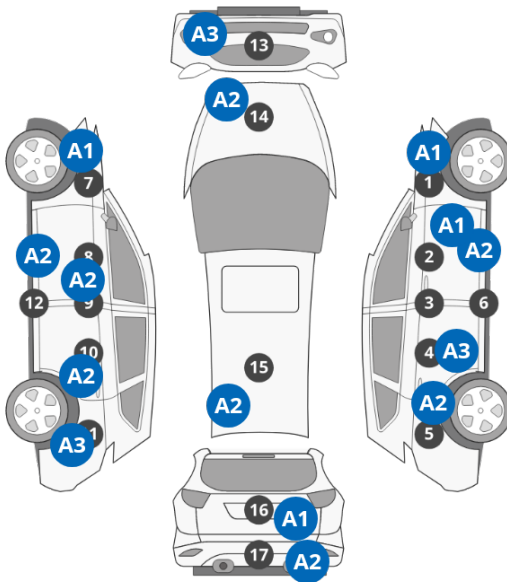
with lto plate/without warranty booklet/with spare mags no tires/with dent and hairlines scratches on the body/with dashcam/with reverse camera/with tools and jack/with rear taillight damage/with spare remote key
