## General Information

| Make | Toyota | Model | Vios |
| Registration No. | NJR1108 | Chassis No. | PA1B18F38S4296794 |

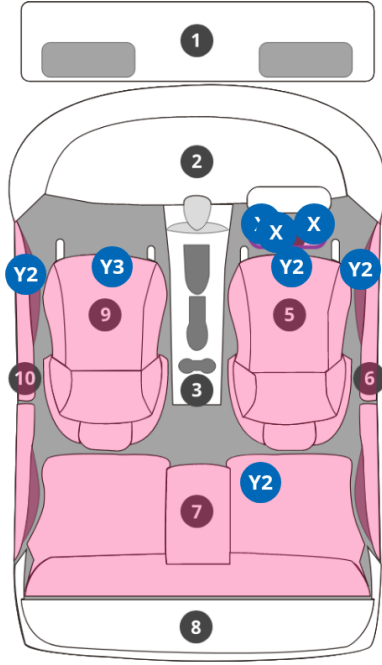
| Interior Evaluation : <b>B</b> | Exterior Evaluation : <b>D</b> |
| <p><b>Remarks</b><br/>(L) Front Floor Mat - Missing - Yes / (R) Front Floor Mat - Missing - Yes / Mat Other - Missing - Yes / (R) Front Seat - Grime - Small / (L) Front Seat - Grime - Medium / Rear Seat - Grime - Small / (L) Front Trim - Grime - Small / (R) Front Trim - Grime - Small</p> | <p><b>Remarks</b><br/>(R) Front Fender, Molding - Scratch - Minimal / (R) Front Door, Molding - Scratch - Minimal / (R) Step, In-panel, Side Spoiler - Scratch - Small / (R) Rear Door, Molding - Scratch - Small / (R) Rear Fender, Molding - Scratch - Small / Rear Bumper, Lamps, Panels - Scratch - Large / Trunk Hood, Rear Gate - Scratch - Minimal / (L) Rear Fender, Molding - Scratch - Minimal / (L) Rear Door, Molding - Scratch - Small / (L) Step, In-panel, Side Spoiler - Scratch - Small / (L) Front Door, Molding - Scratch - Small / (L) Front Fender, Molding - Scratch - Medium / Front Bumper, Grille, Lamps - Scratch - Large / Bonnet, Headlight - Scratch - Small / Roof - Scratch - Minimal</p> |
