## General Information

| Make | Toyota | Model | Hilux Tamaraw |

## Body / Panel Condition

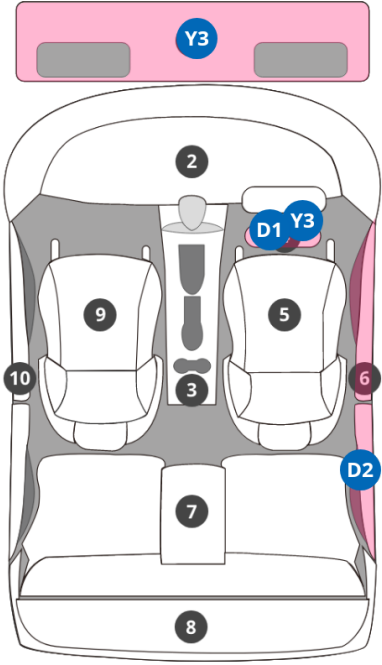
| Interior Evaluation : <b>B</b> | Exterior Evaluation : <b>E</b> |
|---|---|
| <p><b>Remarks</b><br/>Ceiling - Grime - Medium / Trim Other - Worked - Small / (L) Front Floor Mat - Grime - Medium / Carpet - Worked - Minimal</p> | <p><b>Remarks</b><br/>(R) Front Fender, Molding - Scratch - Medium / (R) Mirror - Scratch - Small / (R) Front Door, Molding - Scratch &amp; Dent - Small / (R) Step, In-panel, Side Spoiler - Scratch - Minimal / (R) Side Gate - Scratch &amp; Dent - Large / Rear Gate - Scratch &amp; Dent - Minimal / Rear Bumper, Lamps, Panels - Scratch &amp; Dent - Medium / Cargo Bed Floor - Scratch - Small / (L) Side Gate - Scratch &amp; Dent - Large / Roof - Scratch &amp; Dent - Large / (L) Front Door, Molding - Scratch - Minimal / (L) Step, In-panel, Side Spoiler - Scratch - Minimal / (L) Mirror - Crack - Cracks / (L) Mirror - Scratch - Small / (L) Front Fender, Molding - Scratch - Medium / Front Bumper, Grille, Lamps - Crack, Gap - Large / Bonnet, Headlight - Scratch - Small</p> |
