## General Information

| Make | Toyota | Model | Avanza |

## Body / Panel Condition

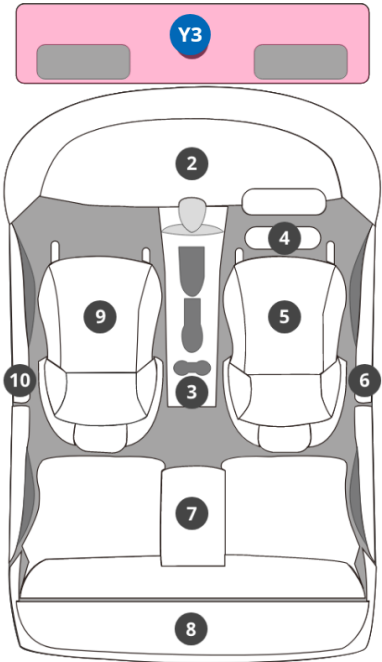
| <b>Interior Evaluation :</b> <b>B</b> | <b>Exterior Evaluation :</b> <b>E</b> |
| <b>Remarks</b><br>Ceiling - Grime - Medium | <b>Remarks</b><br>(R) Front Fender - Repair Traces - Yes / Bonnet - Repair Traces - Yes / (L) Front Fender - Repair Traces - Yes / Front Bumper, Grille, Lamps - Scratch & Dent - Large / (L) Front Fender, Molding - Scratch & Dent - Medium / (L) Mirror - Scratch - Small / (L) Rear Door, Molding - Scratch - Minimal / Rear Bumper, Lamps, Panels - Scratch - Large / (R) Rear Fender, Molding - Dent - Small / (R) Mirror - Scratch - Minimal / (R) Rear Door, Molding - Scratch - Small / (L) Step, In-panel, Side Spoiler - Scratch - Small / Bonnet, Headlight - Crack, Gap - Large / (R) Front Door, Molding - Scratch & Dent - Large |

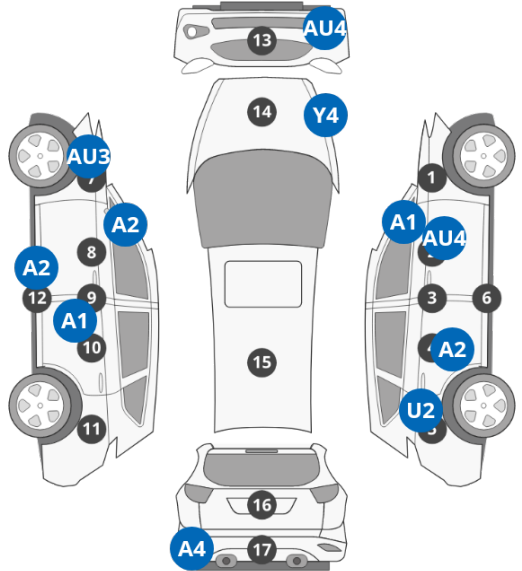
| with warranty booklet, spare tire, jack,. without tools.without LTO plate. gap at the front bumper. |
