## General Information

| Make | Toyota | Model | Hilux Tamaraw |

## Body / Panel Condition

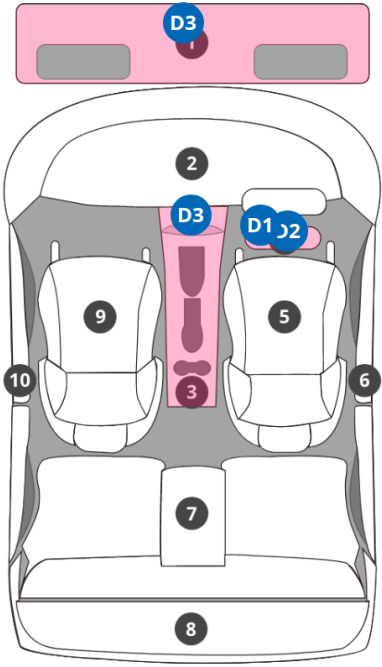
| Interior Evaluation : <b>B</b> | Exterior Evaluation : <b>E</b> |
| <p><b>Remarks</b><br/>Ceiling - Loose, Deformed - Medium / (L) Front Floor Mat - Worked - Small / Console, Switches, Vents - Loose, Deformed - Medium / Carpet - Worked - Minimal</p> | <p><b>Remarks</b><br/>(R) Front Fender, Molding - Scratch - Medium / (R) Mirror - Crack - Damaged / (R) Front Door, Molding - Scratch - Medium / (R) Step, In-panel, Side Spoiler - Scratch - Minimal / (R) Side Gate - Scratch &amp; Dent - Large / Rear Bumper, Lamps, Panels - Scratch &amp; Dent - Medium / Cargo Bed Floor - Scratch - Large / Roof - Scratch &amp; Dent - Small / (L) Side Gate - Scratch - Large / (L) Front Door, Molding - Scratch &amp; Dent - Minimal / (L) Mirror - Scratch - Minimal / (L) Front Fender, Molding - Scratch - Medium / Front Bumper, Grille, Lamps - Crack, Gap - Large / Bonnet, Headlight - Scratch - Large / (L) Step, In-panel, Side Spoiler - Scratch - Small / Rear Gate - Scratch - Medium</p> |

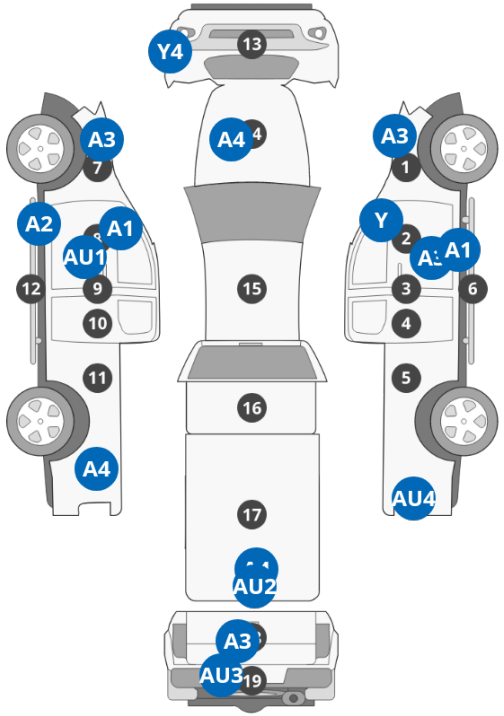
| Inspector Notes |
|---|
| With Lto plate, with spare tire and warranty booklet, 1key, no tools and Jack, Crack taillight, shifting knob partially missing |
