## General Information

| Make | Toyota | Model | Hilux Tamaraw |
| Registration No. | NJC8758 | Chassis No. | PAHACACA46S425796 |

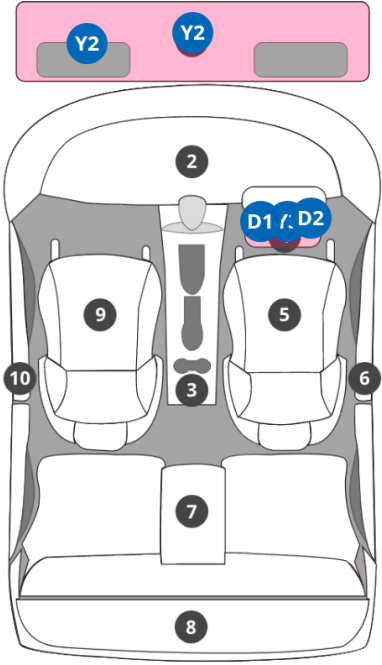
| Interior Evaluation : <b>B</b> | Exterior Evaluation : <b>E</b> |
| <b>Remarks</b><br>(L) Front Floor Mat - Grime - Medium / Carpet - Worked - Minimal / Ceiling - Grime - Small / Sunvisor, Sunglass Holder - Grime - Small / (R) Front Floor Mat - Worked - Small | <b>Remarks</b><br>(R) Front Fender, Molding - Scratch - Minimal / (R) Mirror - Scratch - Small / (R) Front Door, Molding - Scratch & Dent - Large / (R) Step, In-panel, Side Spoiler - Scratch - Minimal / (R) Side Gate - Scratch & Dent - Large / Rear Bumper, Lamps, Panels - Scratch - Small / Cab Back Panel - Scratch & Dent - Large / Cargo Bed Floor - Scratch & Dent - Medium / Rear Gate - Scratch & Dent - Minimal / (L) Side Gate - Scratch & Dent - Large / Roof - Scratch & Dent - Medium / (L) Mirror - Scratch - Minimal / (L) Front Door, Molding - Scratch - Minimal / (L) Front Fender, Molding - Scratch - Minimal / Bonnet, Headlight - Scratch & Dent - Small / Front Bumper, Grille, Lamps - Scratch - Medium / (L) Step, In-panel, Side Spoiler - Scratch - Minimal |

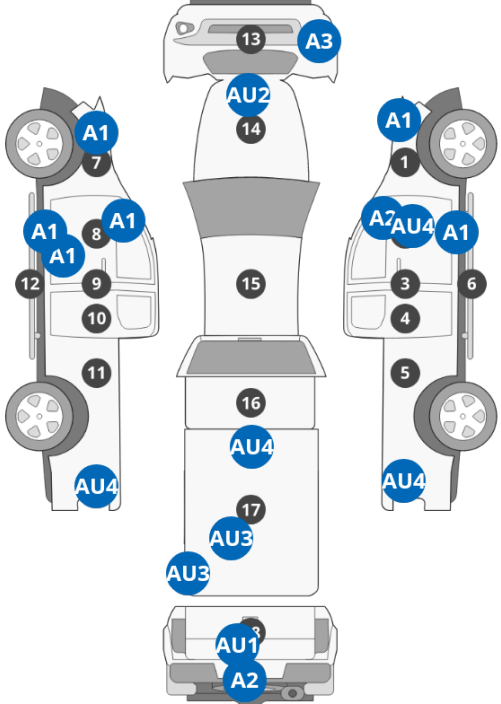
With Lto plate, with spare tire, 2keys, no warranty booklet and tools and Jack, possible flooding, scratches on headlights
