## General Information

| Make | Toyota | Model | Hilux Tamaraw |

## Body / Panel Condition

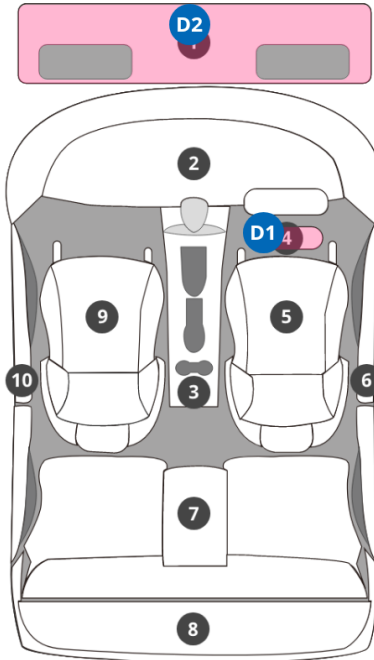
| Interior Evaluation : <span style="color: red; font-weight: bold;">A</span> | | Exterior Evaluation : <span style="color: red; font-weight: bold;">C</span> | |
| <p><b>Remarks</b></p> <p>Ceiling - Loose, Deformed - Small / Carpet - Worked - Minimal</p> | | <p><b>Remarks</b></p> <p>(R) Front Fender, Molding - Scratch - Minimal / (R) Front Door, Molding - Scratch - Minimal / (R) Step, In-panel, Side Spoiler - Scratch - Minimal / (R) Side Gate - Scratch - Medium / Rear Gate - Scratch - Minimal / Rear Bumper, Lamps, Panels - Scratch - Minimal / Cargo Bed Floor - Scratch - Medium / Roof - Scratch &amp; Dent - Large / (L) Front Door, Molding - Scratch - Medium / (L) Front Fender, Molding - Scratch - Minimal / Front Bumper, Grille, Lamps - Scratch - Large / Bonnet, Headlight - Scratch - Minimal / (L) Step, In-panel, Side Spoiler - Scratch - Minimal</p> | |
