## General Information

| Make | Toyota | Model | Vios |

## Body / Panel Condition

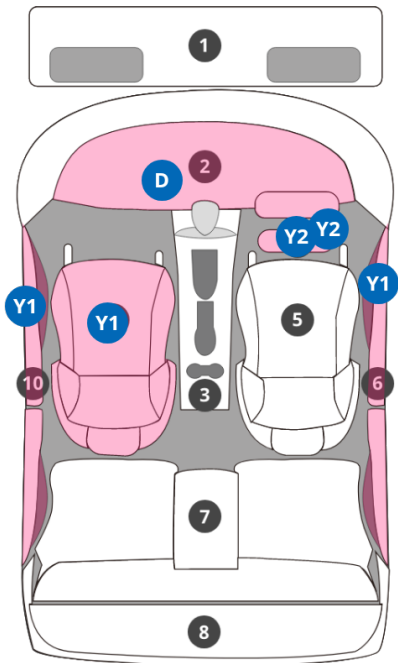
| Interior Evaluation : <b>A</b> | Exterior Evaluation : <b>E</b> |
| <b>Remarks</b><br>(L) Front Floor Mat - Grime - Small / (R) Front Floor Mat - Grime - Small / (L) Front Trim - Grime - Minimal / (R) Front Trim - Grime - Minimal / Dashboard - Traces of Adhesive Tape - Yes / (L) Front Seat - Grime - Minimal | <b>Remarks</b><br>(R) Front Fender - Repair Traces - Yes / Bonnet - Repair Traces - Yes / (L) Front Fender - Repair Traces - Yes / Trunk Hood, Rear Gate - Scratch & Dent - Minimal / Rear Bumper, Lamps, Panels - Scratch & Dent - Medium / (R) Rear Fender, Molding - Scratch & Dent - Small / (R) Rear Door, Molding - Scratch & Dent - Small / (R) Front Door, Molding - Scratch & Dent - Small / (R) Step, In-panel, Side Spoiler - Scratch & Dent - Large / (R) Front Fender, Molding - Scratch & Dent - Small / Front Bumper, Grille, Lamps - Scratch - Large / Bonnet, Headlight - Scratch & Dent - Small / (L) Front Door, Molding - Scratch & Dent - Medium / (L) Front Fender, Molding - Scratch & Dent - Small / (L) Rear Door, Molding - Scratch & Dent - Small / Roof - Scratch & Dent - Small / (L) Rear Fender, Molding - Scratch & Dent - Minimal / (L) Step, In-panel, Side Spoiler - Scratch & Dent - Minimal |

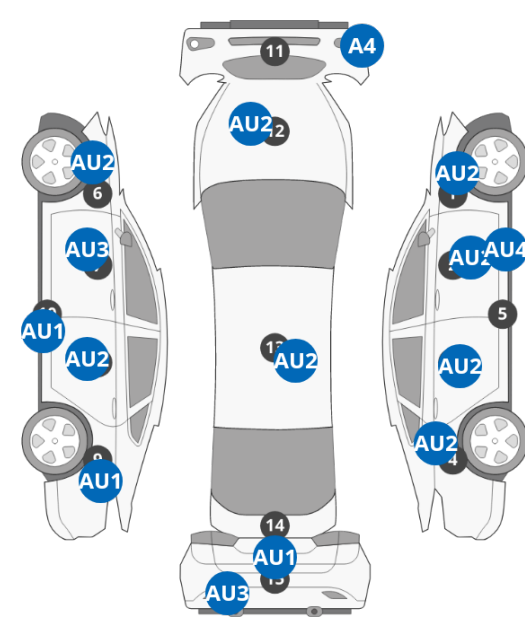
with LTO plate, with spare tire, with jack and inc tools, with reverse camera, no warranty and manual booklet, no spare key, scratches and dent on exterior, scratches in taillight and headlight.
