## General Information

| Make | Toyota | Model | Vios |
| Registration No. | NFR8868 | Chassis No. | PA1B18F38R4258024 |

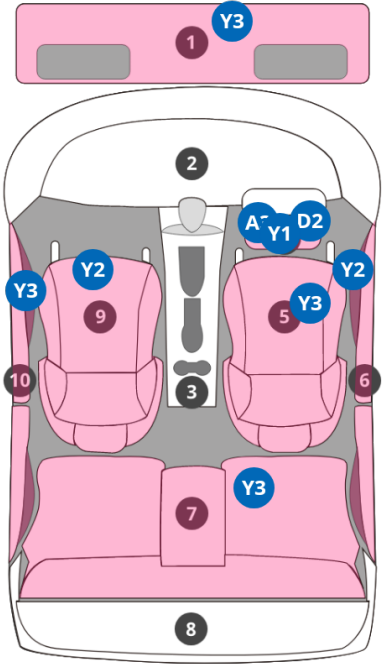
| Interior Evaluation : <span style="color: red;">C</span> | Exterior Evaluation : <span style="color: red;">C</span> |
|---|---|
| <p><b>Remarks</b><br/>(L) Front Floor Mat - Cut, Crack - Medium / (L) Front Seat - Grime - Small / (R) Front Seat - Grime - Medium / Rear Seat - Grime - Medium / (R) Front Floor Mat - Worked - Small / (L) Front Trim - Grime - Medium / (R) Front Trim - Grime - Small / Ceiling - Grime - Medium / Mat Other - Grime - Minimal</p> | <p><b>Remarks</b><br/>(R) Front Fender, Molding - Scratch - Minimal / (R) Front Door, Molding - Scratch - Minimal / (R) Step, In-panel, Side Spoiler - Scratch - Small / (R) Rear Door, Molding - Scratch - Small / (R) Rear Fender, Molding - Scratch - Minimal / Trunk Hood, Rear Gate - Dent - Small / Rear Bumper, Lamps, Panels - Dent - Small / (L) Rear Fender, Molding - Scratch - Minimal / (L) Rear Door, Molding - Scratch - Small / (L) Front Door, Molding - Scratch - Small / (L) Front Fender, Molding - Scratch - Minimal / (L) Step, In-panel, Side Spoiler - Scratch - Small / Front Bumper, Grille, Lamps - Scratch &amp; Dent - Large / Bonnet, Headlight - Scratch &amp; Dent - Medium / Roof - Scratch - Minimal / Member (Bolted) - Dent - Yes</p> |
