## General Information

| Make | Toyota | Model | Wigo |

## Body / Panel Condition

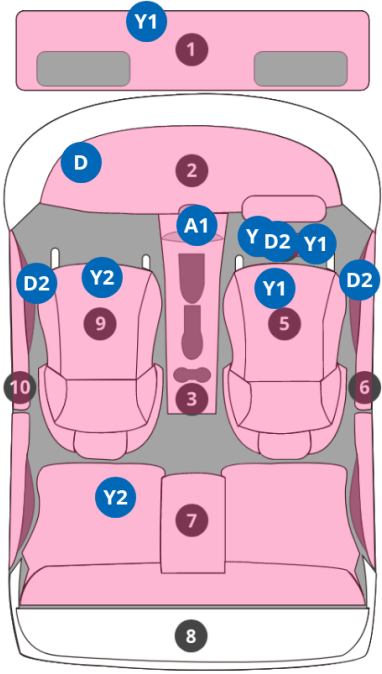
| Interior Evaluation : <b>B</b> | Exterior Evaluation : <b>E</b> |
|---|---|
| <p><b>Remarks</b></p> <p>Dashboard - Traces of Adhesive Tape - Yes / (L) Front Floor Mat - Grime - Minimal / (R) Front Floor Mat - Grime - Minimal / Console, Switches, Vents - Worn, Scratch, Cut, Crack - Minimal / (L) Front Seat - Grime - Small / (R) Front Seat - Grime - Minimal / Rear Seat - Grime - Small / (L) Front Trim - Worked - Small / (R) Front Trim - Worked - Small / Ceiling - Grime - Minimal / Mat Other - Worked - Small</p> | <p><b>Remarks</b></p> <p>(R) Front Fender, Molding - Scratch &amp; Dent - Medium / (R) Front Door, Molding - Scratch - Small / (R) Step, In-panel, Side Spoiler - Scratch &amp; Dent - Large / (R) Rear Door, Molding - Scratch - Small / (R) Rear Fender, Molding - Scratch &amp; Dent - Medium / Rear Bumper, Lamps, Panels - Scratch - Large / Trunk Hood, Rear Gate - Scratch - Minimal / (L) Rear Fender, Molding - Scratch &amp; Dent - Large / (L) Rear Door, Molding - Scratch - Large / (L) Step, In-panel, Side Spoiler - Scratch &amp; Dent - Small / (L) Front Door, Molding - Scratch - Small / (L) Front Fender, Molding - Crack, Gap - Medium / Bonnet, Headlight - Dent - Large / Member (Bolted) - Dent - Yes / Front Bumper, Grille, Lamps - Scratch &amp; Dent - Large / Roof - Scratch - Small / Antennae - Damaged - Yes</p> |
