## General Information

| Make | Toyota | Model | Veloz |
| YOM | 2023 | Mileage | 9,443 |
| Registration No. | NIM6098 | Chassis No. | MHFAB1BY2P3043416 |

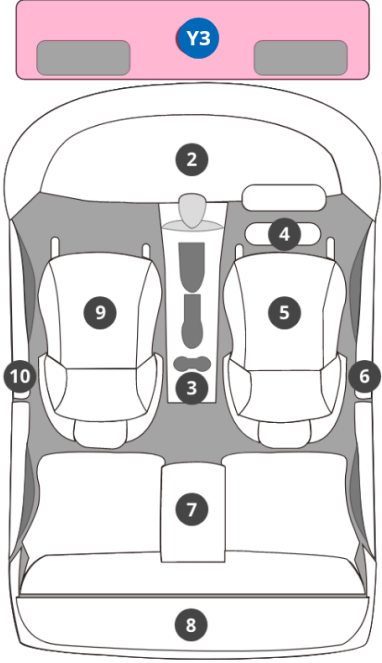
| <b>Interior Evaluation :</b> <b>B</b> | <b>Exterior Evaluation :</b> <b>C</b> |
| <b>Remarks</b><br>Ceiling - Grime - Medium | <b>Remarks</b><br>(R) Front Door, Molding - Scratch - Small / (R) Rear Fender, Molding - Scratch & Dent - Small / Rear Bumper, Lamps, Panels - Scratch - Large / (L) Rear Door, Molding - Scratch - Small / Front Bumper, Grille, Lamps - Scratch - Small / Bonnet, Headlight - Scratch - Minimal / Roof - Dent - Large |

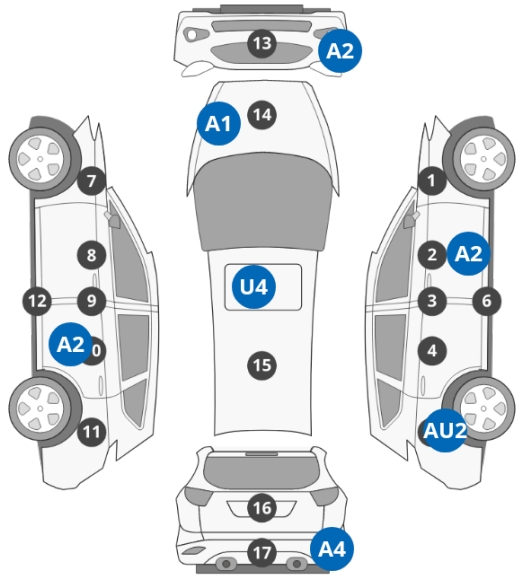
| Inspector Notes |
|---|
| with warranty booklet, no jack and incomplete tools, with spare tire, with LTO plate, with light scratches on front left door |
