## General Information

| Make | Toyota | Model | Vios |
| Registration No. | CCD4154 | Chassis No. | PA1B18F36R4256062 |

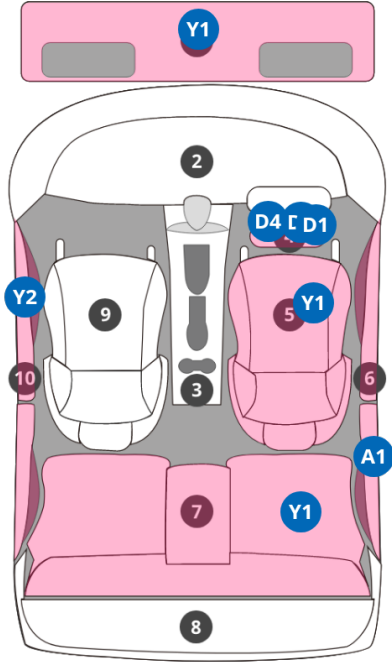
| Interior Evaluation : <span style="color: red;">C</span> | Exterior Evaluation : <span style="color: red;">E</span> |
|---|---|
| <p><b>Remarks</b></p> <p>Ceiling - Grime - Minimal / Rear Seat - Grime - Minimal / (R) Rear Trim - Cut, Crack - Minimal / (R) Front Floor Mat - Worked - Small / (R) Front Seat - Grime - Minimal / (L) Front Trim - Grime - Small / (L) Front Floor Mat - Worked - Large / Carpet - Worked - Minimal</p> | <p><b>Remarks</b></p> <p>(R) Rear Fender - Repair Traces - Yes / (R) Front Fender, Molding - Scratch - Minimal / (R) Mirror - Scratch - Minimal / (R) Front Door, Molding - Scratch &amp; Dent - Minimal / (R) Rear Door, Molding - Scratch - Small / (R) Step, In-panel, Side Spoiler - Scratch - Minimal / (R) Rear Fender, Molding - Scratch - Minimal / Rear Bumper, Lamps, Panels - Scratch - Large / Trunk Hood, Rear Gate - Scratch &amp; Dent - Medium / (L) Rear Fender, Molding - Scratch &amp; Dent - Large / (L) Rear Door, Molding - Scratch &amp; Dent - Large / (L) Step, In-panel, Side Spoiler - Scratch - Minimal / (L) Front Door, Molding - Scratch - Small / (L) Mirror - Scratch - Minimal / (L) Front Fender, Molding - Scratch - Medium / Front Bumper, Grille, Lamps - Scratch - Large / Bonnet, Headlight - Scratch - Minimal / Roof - Scratch - Minimal</p> |

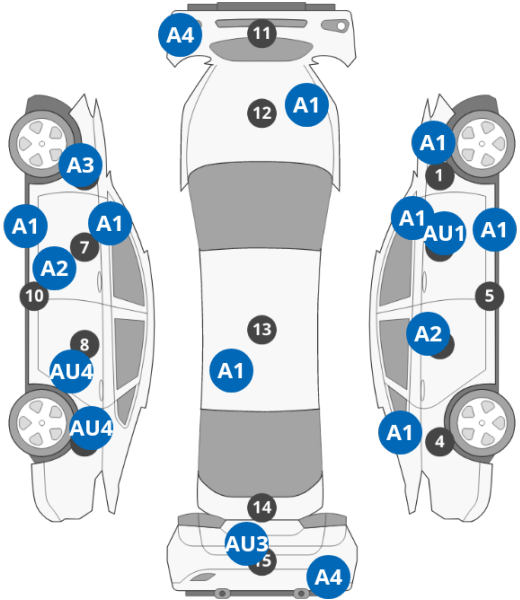
| Inspector Notes |
|---|
| With Lto plate, with spare and jack, 1key, no warranty booklet and tools, scratches on headlights and taillights, worn tires |
