## General Information

| Make | Toyota | Model | Vios |
| YOM | 2023 | Odo Meter Reading | 80,210 |
| Registration No. | CCB3223 | Chassis No. | PA1B18F36P4221731 |

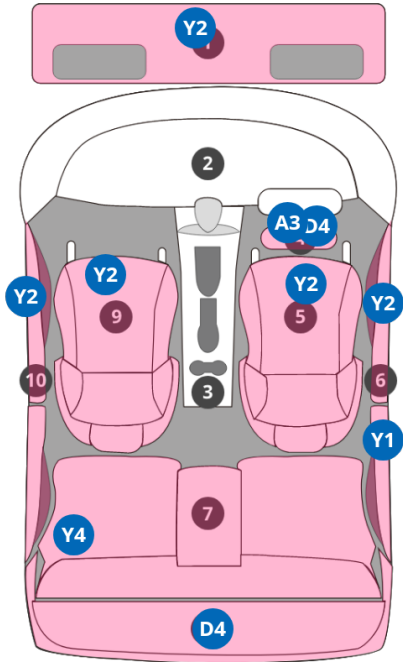
| <b>Remarks</b><br>Ceiling - Grime - Small / Room Mirror - Missing - Yes / (R) Rear Trim - Grime - Minimal / Rear Seat - Grime - Large / (R) Front Trim - Grime - Small / Carpet - Worked - Large / Trunk Room - Worked - Large / (L) Front Trim - Grime - Small / (L) Front Seat - Grime - Small / (R) Front Seat - Grime - Small / (L) Front Floor Mat - Cut, Crack - Medium | <b>Remarks</b><br>(R) Front Fender, Molding - Scratch - Minimal / (R) Front Door, Molding - Scratch & Dent - Minimal / (R) Step, In-panel, Side Spoiler - Scratch & Dent - Small / (R) Rear Door, Molding - Scratch - Minimal / (R) Rear Fender, Molding - Scratch - Small / Rear Bumper, Lamps, Panels - Scratch & Dent - Large / Trunk Hood, Rear Gate - Scratch & Dent - Medium / (L) Rear Fender, Molding - Scratch & Dent - Minimal / (L) Rear Door, Molding - Scratch - Minimal / (L) Front Door, Molding - Scratch - Small / Roof - Scratch - Minimal / (L) Front Fender, Molding - Scratch - Minimal / (L) Step, In-panel, Side Spoiler - Scratch - Small / Member (Bolted) - Dent - Yes / Front Bumper, Grille, Lamps - Scratch & Dent - Large / Bonnet, Headlight - Scratch - Small |

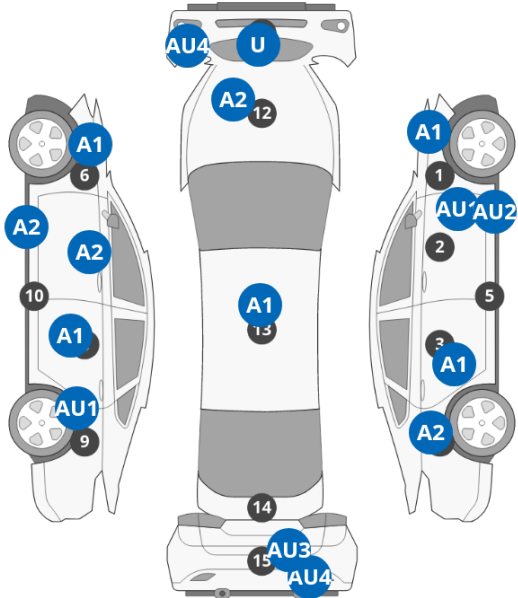
| Inspector Notes |
|---|
| With Lto plate, with jack, 1key, no spare tire and warranty booklet and tools, scratches on headlights and taillights |
