## General Information

| Make | Toyota | Model | Vios |

## Body / Panel Condition

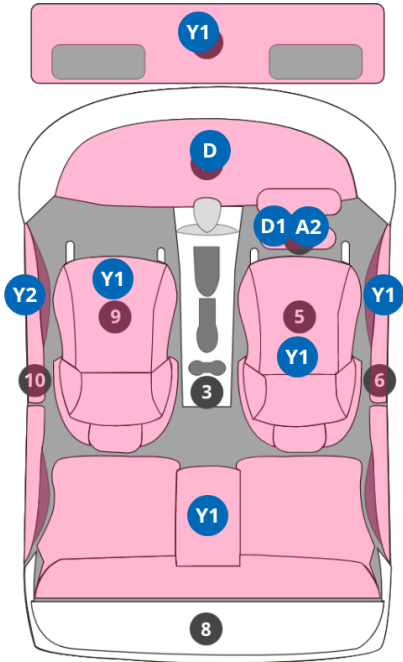
| Interior Evaluation : <span style="color: red; font-weight: bold;">B</span> | | Exterior Evaluation : <span style="color: red; font-weight: bold;">C</span> | |
|---|--|---|--|
| <p><b>Remarks</b></p> <p>Ceiling - Grime - Minimal / Rear Seat - Grime - Minimal / (R) Front Trim - Grime - Minimal / Dashboard - Traces of Adhesive Tape - Yes / (R) Front Seat - Grime - Minimal / (L) Front Trim - Grime - Small / (L) Front Floor Mat - Cut, Crack - Small / Carpet - Worked - Minimal / (L) Front Seat - Grime - Minimal</p> | | <p><b>Remarks</b></p> <p>(R) Front Fender, Molding - Scratch &amp; Dent - Minimal / (R) Mirror - Scratch - Minimal / (R) Front Door, Molding - Scratch - Minimal / (R) Step, In-panel, Side Spoiler - Scratch - Minimal / (R) Rear Door, Molding - Scratch - Small / (R) Rear Fender, Molding - Scratch - Minimal / Rear Bumper, Lamps, Panels - Scratch &amp; Dent - Large / Trunk Hood, Rear Gate - Scratch - Minimal / (L) Rear Fender, Molding - Scratch &amp; Dent - Minimal / (L) Rear Door, Molding - Scratch &amp; Dent - Minimal / (L) Front Door, Molding - Scratch - Minimal / (L) Step, In-panel, Side Spoiler - Scratch - Minimal / (L) Front Fender, Molding - Scratch - Minimal / Front Bumper, Grille, Lamps - Scratch &amp; Dent - Large / Bonnet, Headlight - Scratch - Minimal</p> | |

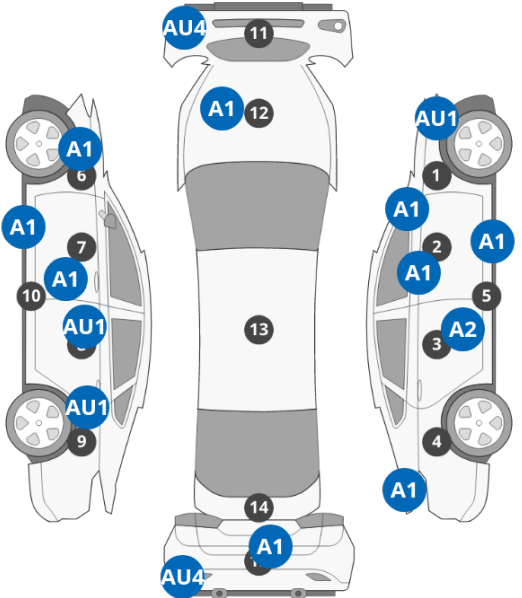
With Lto plate, with spare tire and jack, with warranty booklet and tools, 3keys, scratches on headlights and taillights,
