## General Information

| Make | Toyota | Model | Vios |
| YOM | 2023 | Odo Meter Reading | 90,748 |
| Registration No. | NHI5672 | Chassis No. | PA1B18F35P4204144 |

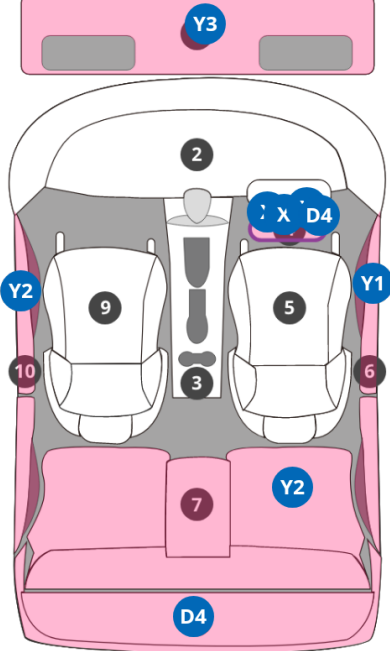
| Interior Evaluation : <b>C</b> | Exterior Evaluation : <b>E</b> |
| <p><b>Remarks</b><br/>Mat Other - Missing - Yes / (R) Front Floor Mat - Missing - Yes / (L) Front Floor Mat - Missing - Yes / Ceiling - Grime - Medium / Rear Seat - Grime - Small / (R) Front Trim - Grime - Minimal / Trunk Room - Loose, Deformed - Large / (L) Front Trim - Grime - Small / Carpet - Worked - Large</p> | <p><b>Remarks</b><br/>(R) Rear Door - Repair Traces - Yes / (R) Front Fender, Molding - Scratch - Minimal / (R) Mirror - Scratch - Minimal / (R) Front Door, Molding - Scratch &amp; Dent - Small / (R) Step, In-panel, Side Spoiler - Scratch - Minimal / (R) Rear Door, Molding - Repair mark - Yes / (R) Rear Door, Molding - Scratch - Medium / (R) Rear Fender, Molding - Scratch &amp; Dent - Small / Rear Bumper, Lamps, Panels - Scratch &amp; Dent - Small / Trunk Hood, Rear Gate - Scratch &amp; Dent - Minimal / (L) Rear Fender, Molding - Scratch - Minimal / (L) Rear Door, Molding - Scratch &amp; Dent - Large / (L) Front Door, Molding - Scratch &amp; Dent - Large / Roof - Scratch &amp; Dent - Small / (L) Mirror - Scratch - Minimal / (L) Step, In-panel, Side Spoiler - Scratch - Minimal / (L) Front Fender, Molding - Scratch &amp; Dent - Minimal / Front Bumper, Grille, Lamps - Scratch &amp; Dent - Large / Bonnet, Headlight - Scratch - Minimal / Roof Spoiler, Molding - Scratch &amp; Dent - Minimal / Member (Bolted) - Dent - Yes</p> |
