## General Information

| Make | Toyota | Model | Vios |
| YOM | 2016 | Odo Meter Reading | 84,576 |
| Registration No. | DEB1065 | Chassis No. | PA1BW9F36G2080758 |

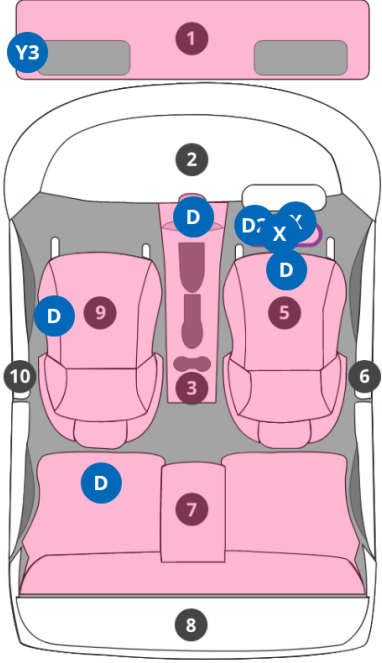
| Interior Evaluation : <b>C</b> | Exterior Evaluation : <b>E</b> |
|---|---|
| <b>Remarks</b><br>(L) Front Seat - Worn - Yes / (R) Front Seat - Worn - Yes / (L) Front Floor Mat - Worked - Small / (R) Front Floor Mat - Missing - Yes / Mat Other - Missing - Yes / Console, Switches, Vents - Traces of Adhesive Tape - Yes / Ceiling - Grime - Medium / Rear Seat - Worn - Yes | <b>Remarks</b><br>(R) Front Fender, Molding - Scratch & Dent - Small / (R) Mirror - Scratch - Small / (R) Step, In-panel, Side Spoiler - Scratch & Dent - Large / (R) Rear Door, Molding - Scratch & Dent - Large / (R) Front Door, Molding - Scratch & Dent - Medium / (R) Rear Fender, Molding - Repair mark - Yes / (R) Rear Fender, Molding - Scratch & Dent - Large / Rear Bumper, Lamps, Panels - Repair mark - Yes / Rear Bumper, Lamps, Panels - Scratch & Dent - Large / Trunk Hood, Rear Gate - Scratch - Small / (L) Rear Fender, Molding - Repair mark - Yes / (L) Rear Fender, Molding - Scratch & Dent - Large / (L) Rear Door, Molding - Repair mark - Yes / (L) Front Door, Molding - Scratch & Dent - Large / (L) Step, In-panel, Side Spoiler - Dent - Small / (L) Mirror - Scratch - Small / (L) Front Fender, Molding - Scratch - Medium / Member (Bolted) - Dent - Yes / Front Bumper, Grille, Lamps - Repair mark - Yes / Front Bumper, Grille, Lamps - Scratch & Dent - Large / Bonnet, Headlight - Scratch - Small / Roof - Scratch - Medium |
