## General Information

| Make | Toyota | Model | Vios |

## Body / Panel Condition

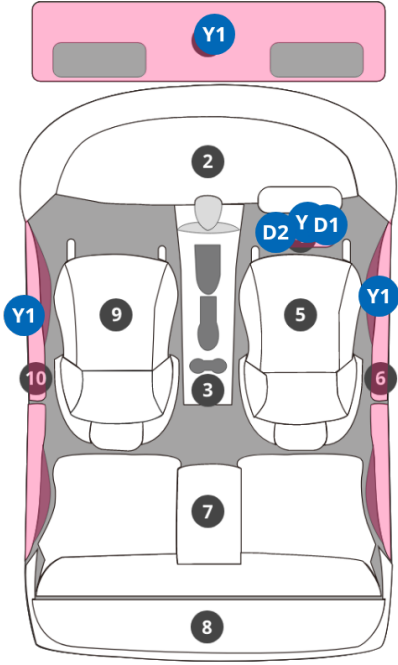
| Interior Evaluation : <b>B</b> | Exterior Evaluation : <b>C</b> |
|---|---|
| <b>Remarks</b><br>Ceiling - Grime - Minimal / Mat Other - Grime - Medium / (R) Front Trim - Grime - Minimal / (L) Front Floor Mat - Worked - Small / Carpet - Worked - Minimal / (L) Front Trim - Grime - Minimal | <b>Remarks</b><br>(R) Front Fender, Molding - Scratch & Dent - Small / (R) Mirror - Scratch - Minimal / (R) Front Door, Molding - Scratch - Small / (R) Rear Door, Molding - Scratch - Small / (R) Step, In-panel, Side Spoiler - Scratch - Minimal / (R) Rear Fender, Molding - Scratch - Small / Rear Bumper, Lamps, Panels - Crack, Gap - Large / Trunk Hood, Rear Gate - Scratch - Minimal / (L) Rear Fender, Molding - Scratch - Minimal / (L) Rear Door, Molding - Scratch - Minimal / (L) Front Door, Molding - Scratch - Minimal / (L) Step, In-panel, Side Spoiler - Scratch - Minimal / (L) Mirror - Scratch - Minimal / (L) Front Fender, Molding - Scratch - Minimal / Front Bumper, Grille, Lamps - Scratch & Dent - Large / Bonnet, Headlight - Scratch - Minimal |

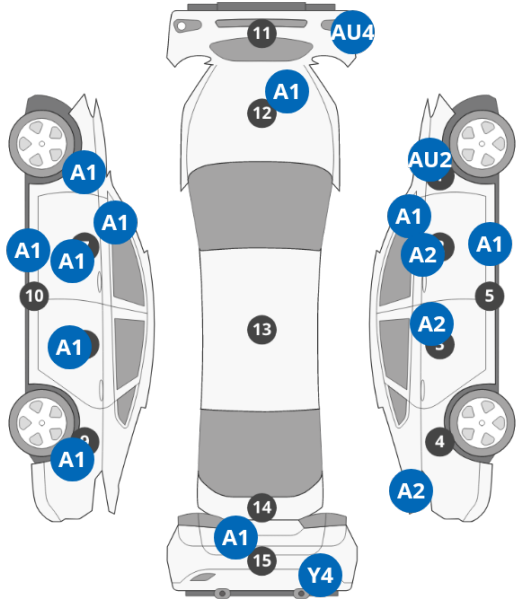
| Inspector Notes |
|---|
| With Lto plate, with spare tire and jack, with warranty booklet, 1key, no tools, scratches on headlights, Crack taillight |
