## General Information

| Make | Toyota | Model | Avanza |
| Registration No. | DAQ6985 | Chassis No. | MHFAA1BY2N0004038 |

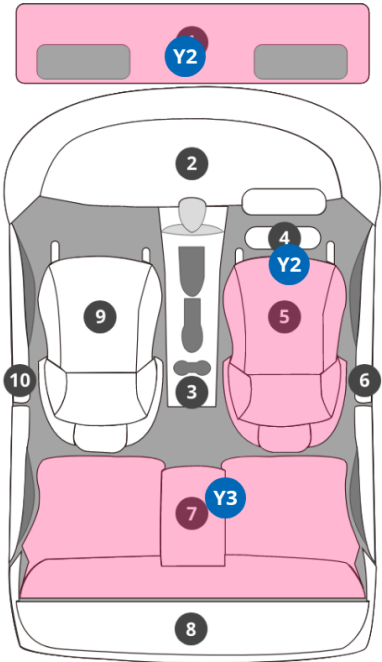
| <b>Interior Evaluation :</b> <b>B</b> | <b>Exterior Evaluation :</b> <b>C</b> |
| <b>Remarks</b><br>Rear Seat - Grime - Medium / (R) Front Seat - Grime - Small / Ceiling - Grime - Small | <b>Remarks</b><br>(R) Front Fender - Repair Traces - Yes / Bonnet - Repair Traces - Yes / (L) Front Door - Repair Traces - Yes / (L) Rear Door - Repair Traces - Yes / (L) Rear Fender - Repair Traces - Yes / Trunk Hood, Rear Gate - Repair Traces - Yes / (R) Rear Fender - Repair Traces - Yes / Roof - Repair Traces - Yes / (R) Front Fender, Molding - Scratch - Minimal / (R) Front Door, Molding - Scratch - Medium / (R) Rear Door, Molding - Scratch & Dent - Small / (R) Rear Fender, Molding - Scratch & Dent - Medium / Rear Bumper, Lamps, Panels - Scratch & Dent - Large / (L) Rear Fender, Molding - Scratch - Small / (L) Rear Door, Molding - Dent - Minimal / (L) Mirror - Scratch - Minimal / Front Bumper, Grille, Lamps - Scratch & Dent - Large / Roof - Scratch - Small |
