## General Information

| Make | Toyota | Model | Vios |

## Body / Panel Condition

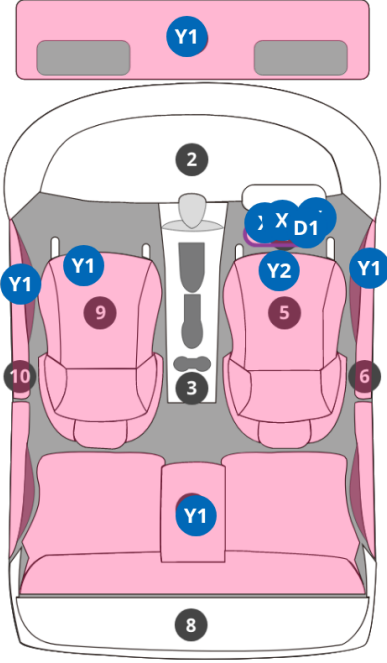
| Interior Evaluation : <b>B</b> | Exterior Evaluation : <b>C</b> |
| <p><b>Remarks</b></p> <p>Ceiling - Grime - Minimal / (R) Front Floor Mat - Missing - Yes / (L) Front Floor Mat - Missing - Yes / Mat Other - Missing - Yes / Rear Seat - Grime - Minimal / (R) Front Trim - Grime - Minimal / (R) Front Seat - Grime - Small / (L) Front Trim - Grime - Minimal / Carpet - Worked - Minimal / (L) Front Seat - Grime - Minimal</p> | <p><b>Remarks</b></p> <p>Bonnet - Repair Traces - Yes / Bonnet, Headlight - Repair mark - Yes / Front Windshield - Scratch, Stone chip - Medium / (R) Front Fender, Molding - Scratch &amp; Dent - Minimal / (R) Mirror - Scratch - Minimal / (R) Front Door, Molding - Scratch - Minimal / (R) Step, In-panel, Side Spoiler - Scratch - Small / (R) Rear Door, Molding - Scratch - Minimal / (R) Rear Fender, Molding - Scratch - Minimal / Rear Bumper, Lamps, Panels - Scratch - Small / Trunk Hood, Rear Gate - Scratch - Minimal / (L) Rear Fender, Molding - Scratch - Small / (L) Rear Door, Molding - Scratch - Minimal / (L) Front Door, Molding - Scratch - Minimal / (L) Step, In-panel, Side Spoiler - Scratch - Minimal / (L) Mirror - Scratch - Minimal / (L) Front Fender, Molding - Scratch - Minimal / Front Bumper, Grille, Lamps - Scratch &amp; Dent - Small / Bonnet, Headlight - Scratch - Small / Roof - Scratch - Minimal</p> |

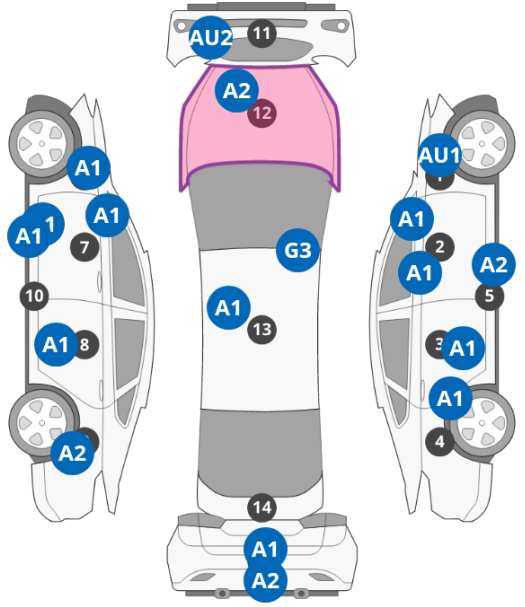
| Inspector Notes |
|---|
| With Lto plate ,with spare tire and warranty booklet, 1key, no jack and tools, scratches on taillights, battery weak |
