## General Information

| Make | Toyota | Model | Vios |
| Registration No. | CCR3054 | Chassis No. | PA1B18F34S4292192 |

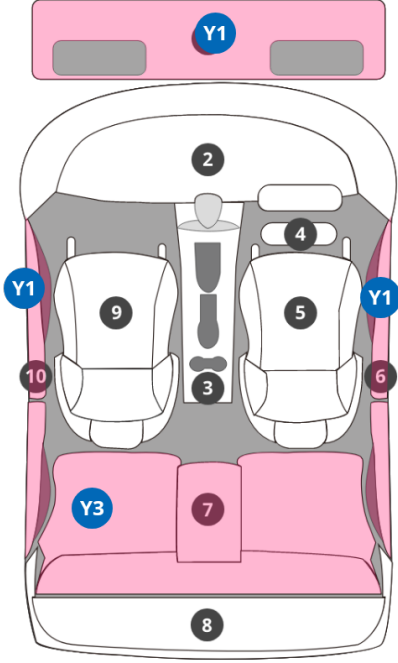
| Interior Evaluation : <b>B</b> | Exterior Evaluation : <b>E</b> |
| <p><b>Remarks</b><br/>Ceiling - Grime - Minimal / Rear Seat - Grime - Medium / (R) Front Trim - Grime - Minimal / (L) Front Trim - Grime - Minimal</p> | <p><b>Remarks</b><br/>(L) Front Fender - Repair Traces - Yes / (R) Front Fender, Molding - Scratch - Minimal / (R) Mirror - Scratch - Minimal / (R) Front Door, Molding - Scratch - Small / (R) Step, In-panel, Side Spoiler - Scratch - Minimal / (R) Rear Door, Molding - Scratch &amp; Dent - Small / Rear Windshield - Damaged - Large / Trunk Hood, Rear Gate - Scratch &amp; Dent - Medium / Rear Bumper, Lamps, Panels - Crack, Gap - Large / (R) Rear Fender, Molding - Scratch &amp; Dent - Large / (L) Rear Fender, Molding - Scratch &amp; Dent - Small / (L) Rear Door, Molding - Scratch - Minimal / (L) Front Door, Molding - Repair mark - Yes / (L) Front Door, Molding - Scratch - Minimal / (L) Step, In-panel, Side Spoiler - Scratch - Minimal / (L) Front Fender, Molding - Scratch &amp; Dent - Minimal / Roof - Scratch - Minimal / Front Bumper, Grille, Lamps - Scratch - Large / Bonnet, Headlight - Scratch - Minimal</p> |

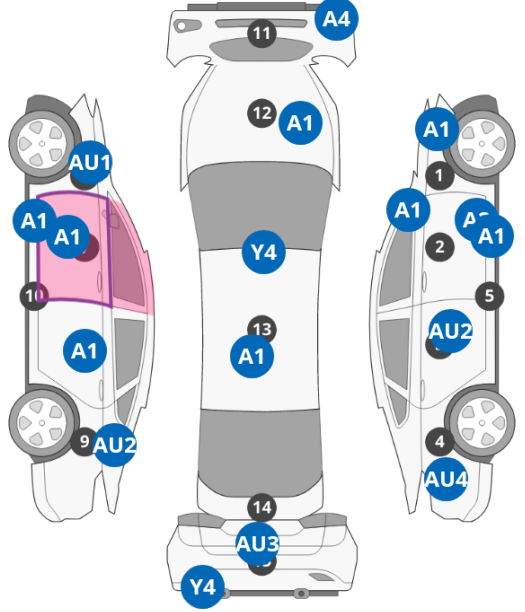
| Inspector Notes |
|---|
| With Lto plate, with jack, 1key, NO warranty booklet and spare tire and tools ,scratches on headlights, Crack taillight , |
