## General Information

| Make | Toyota | Model | Vios |
| YOM | 2024 | Odo Meter Reading | 49,178 |
| Registration No. | CCC4303 | Chassis No. | PA1B18F33P4238390 |

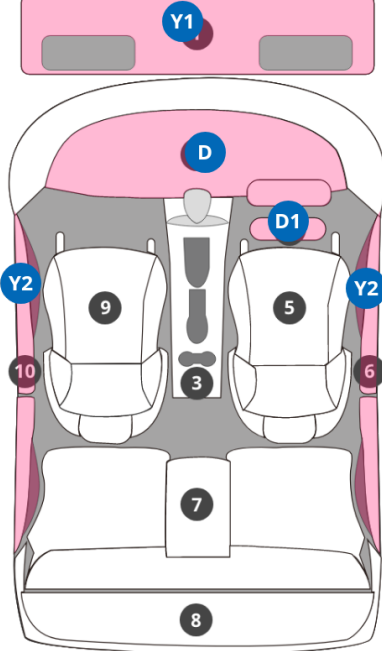
| Interior Evaluation : <b>A</b> | Exterior Evaluation : <b>C</b> |
| <p><b>Remarks</b><br/>Ceiling - Grime - Minimal / (R) Front Trim - Grime - Small / (L) Front Trim - Grime - Small / Carpet - Worked - Minimal / Dashboard - Traces of Adhesive Tape - Yes</p> | <p><b>Remarks</b><br/>(R) Front Door - Repair Traces - Yes / (R) Front Fender - Repair Traces - Yes / (R) Front Fender, Molding - Repair mark - Yes / (R) Front Fender, Molding - Scratch &amp; Dent - Minimal / (R) Mirror - Scratch - Minimal / (R) Front Door, Molding - Repair mark - Yes / (R) Front Door, Molding - Scratch - Minimal / (R) Step, In-panel, Side Spoiler - Scratch - Minimal / (R) Rear Door, Molding - Scratch - Minimal / (R) Rear Fender, Molding - Scratch - Minimal / Rear Bumper, Lamps, Panels - Scratch - Large / Trunk Hood, Rear Gate - Scratch - Minimal / (L) Rear Fender, Molding - Scratch - Minimal / (L) Rear Door, Molding - Scratch - Small / (L) Front Door, Molding - Scratch - Minimal / (L) Step, In-panel, Side Spoiler - Scratch - Minimal / (L) Front Fender, Molding - Scratch - Minimal / Front Bumper, Grille, Lamps - Scratch - Medium / Bonnet, Headlight - Dent - Medium / (R) Rear Door, Molding - Repair mark - Yes</p> |
