## General Information

| Make | Toyota | Model | Vios |

## Body / Panel Condition

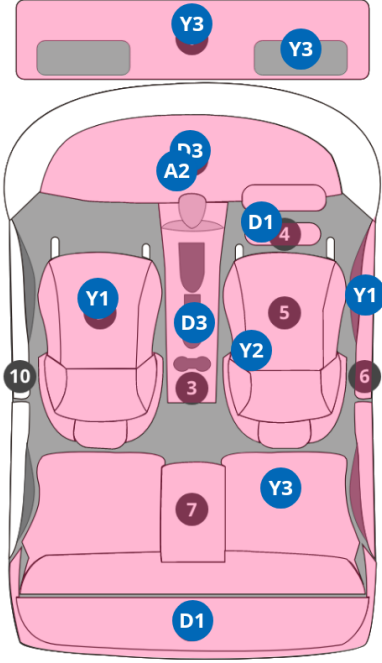
| Interior Evaluation : <b>C</b> | Exterior Evaluation : <b>E</b> |
| <p><b>Remarks</b></p> <p>Overall Interior - Worn as per age - Yes / Ceiling - Grime - Medium / Sunvisor, Sunglass Holder - Grime - Medium / Rear Seat - Grime - Medium / (R) Front Trim - Grime - Minimal / (R) Front Seat - Grime - Small / Trunk Room - Worked - Minimal / (L) Front Seat - Grime - Minimal / Carpet - Worked - Minimal / Dashboard - Loose, Deformed - Medium / Steering Wheel - Worn, Peel, Crack - Small / Console, Switches, Vents - Loose, Deformed - Medium</p> | <p><b>Remarks</b></p> <p>(R) Front Door - Repair Traces - Yes / (R) Front Fender - Repair Traces - Yes / (R) Rear Fender - Repair Traces - Yes / (R) Front Fender, Molding - Repair mark - Yes / (R) Front Fender, Molding - Scratch &amp; Dent - Small / (R) Mirror - Faded(Color, Gloss) - Yes / (R) Mirror - Scratch - Minimal / (R) Front Door, Molding - Repair mark - Yes / (R) Front Door, Molding - Scratch &amp; Dent - Large / (R) Step, In-panel, Side Spoiler - Scratch &amp; Dent - Large / (R) Rear Door, Molding - Scratch - Small / (R) Rear Fender, Molding - Repair mark - Yes / (R) Rear Fender, Molding - Scratch &amp; Dent - Large / Rear Bumper, Lamps, Panels - Scratch &amp; Dent - Large / Trunk Hood, Rear Gate - Scratch - Small / (L) Rear Fender, Molding - Scratch &amp; Dent - Medium / (L) Rear Door, Molding - Scratch &amp; Dent - Minimal / (L) Front Door, Molding - Scratch - Medium / (L) Mirror - Faded(Color, Gloss) - Yes / (L) Front Fender, Molding - Scratch &amp; Dent - Small / (L) Step, In-panel, Side Spoiler - Scratch - Small / Front Bumper, Grille, Lamps - Scratch &amp; Dent - Large / Bonnet, Headlight - Scratch - Minimal / Roof - Scratch - Minimal</p> |

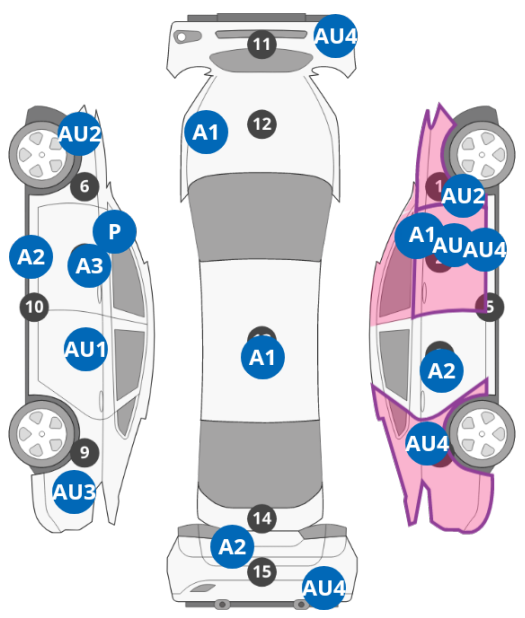
| Inspector Notes |
|---|
| With Lto plate, with spare tire and jack, with warranty booklet, 1key, no tools, faded headlights, scratches on taillights, trunk door latch issue,plate light issue |
