## General Information

| Make | Toyota | Model | Innova |
| YOM | 2022 | Odo Meter Reading | 106,476 |

## Body / Panel Condition

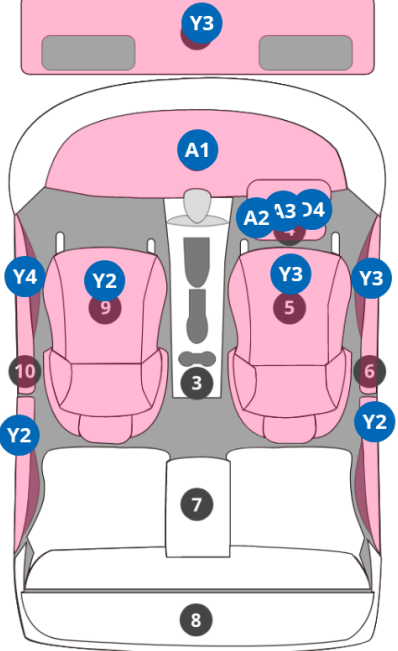
| Interior Evaluation : <b>D</b> | Exterior Evaluation : <b>E</b> |
| <b>Remarks</b><br>Ceiling - Grime - Medium / (R) Front Trim - Grime - Medium / (R) Front Seat - Grime - Medium / Mat Other - Worked - Large / (R) Rear Trim - Grime - Small / (L) Rear Trim - Grime - Small / (L) Front Trim - Grime - Large / (L) Front Seat - Grime - Small / (L) Front Floor Mat - Cut, Crack - Medium / Carpet - Worn, Scratch, Cut, Crack - Small / Dashboard - Worn, Scratch, Cut, Crack - Minimal / Overall Interior - Worn as per age - Yes | <b>Remarks</b><br>(R) Front Door - Repair Traces - Yes / (R) Front Fender - Repair Traces - Yes / Bonnet - Repair Traces - Yes / (L) Front Fender - Repair Traces - Yes / (L) Front Door - Repair Traces - Yes / (L) Rear Door - Repair Traces - Yes / (L) Rear Fender - Repair Traces - Yes / Trunk Hood, Rear Gate - Repair Traces - Yes / (R) Rear Fender - Repair Traces - Yes / (R) Rear Door - Repair Traces - Yes / Roof - Repair Traces - Yes / (R) Front Fender, Molding - Repair mark - Yes / (R) Front Fender, Molding - Scratch - Large / (R) Mirror - Scratch - Minimal / (R) Front Door, Molding - Repair mark - Yes / (R) Front Door, Molding - Scratch & Dent - Medium / (R) Rear Door, Molding - Scratch & Dent - Medium / (R) Step, In-panel, Side Spoiler - Scratch - Small / (R) Rear Fender, Molding - Scratch & Dent - Small / Rear Bumper, Lamps, Panels - Scratch & Dent - Large / Trunk Hood, Rear Gate - Scratch & Dent - Large / Trunk Hood, Rear Gate - Repair mark - Yes / (L) Rear Fender, Molding - Repair mark - Yes / (L) Rear Fender, Molding - Scratch - Small / (L) Rear Door, Molding - Scratch & Dent - Small / (L) Front Door, Molding - Scratch & Dent - Medium / Roof - Scratch & Dent - Minimal / (L) Step, In-panel, Side Spoiler - Scratch - Small / (L) Mirror - Scratch - Minimal / (L) Front Fender, Molding - Repair mark - Yes / (L) Front Fender, Molding - Scratch - Large / (L) Rear Tyre - Crack, Cut - Yes / (R) Rear Tyre - Crack, Cut - Yes / (R) Front Tyre - Crack, Cut - Yes / (L) Front Tyre - Crack, Cut - Yes / Front Bumper, Grille, Lamps - Modified - Small / Front Bumper, Grille, Lamps - Repair mark - Yes / Front Bumper, Grille, Lamps - Scratch & Dent - Large / Bonnet, Headlight - Repair mark - Yes / Bonnet, Headlight - Scratch & Dent - Small |

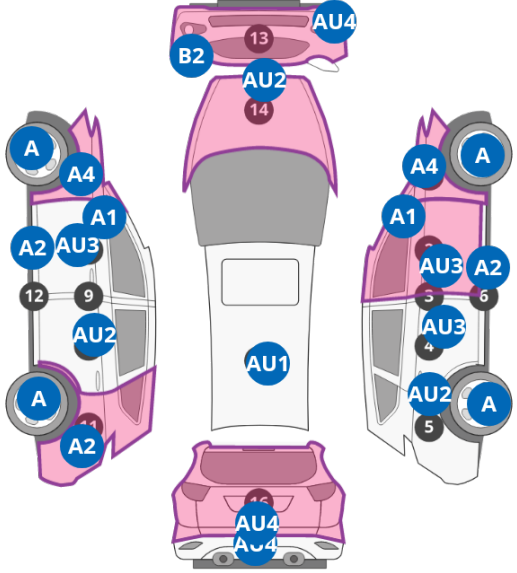
| Interior Evaluation : <b>D</b> | Exterior Evaluation : <b>E</b> |
|---|---|
| <b>Remarks</b><br>Front Cross Member Support - Traces of Bending, or Marks of Panel Repair ? - Yes / Right Front Inside Panel (Front Side) - Traces of Bending, or Marks of Panel Repair ? - Yes / Rear Side Member & Trunk Room Floor - Traces of Bending, or Marks of Panel Repair ? - Yes | <b>Remarks</b><br>Warning Lamps - Issue - Yes / Battery - Weak - Yes / Reverse Camera - N/A - Yes / Brake Pedal - Function - Weak / Spare Key - Issue - Unexist |
