## General Information

| Make | Toyota | Model | Vios |
| YOM | 2026 | Odo Meter Reading | 22,661 |
| Registration No. | NJK5176 | Chassis No. | PA1B18F34S4295867 |

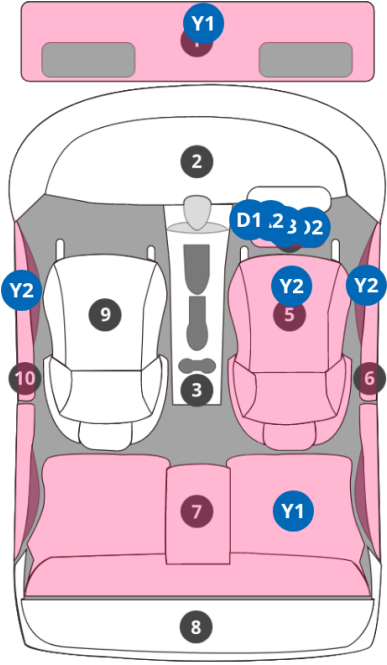
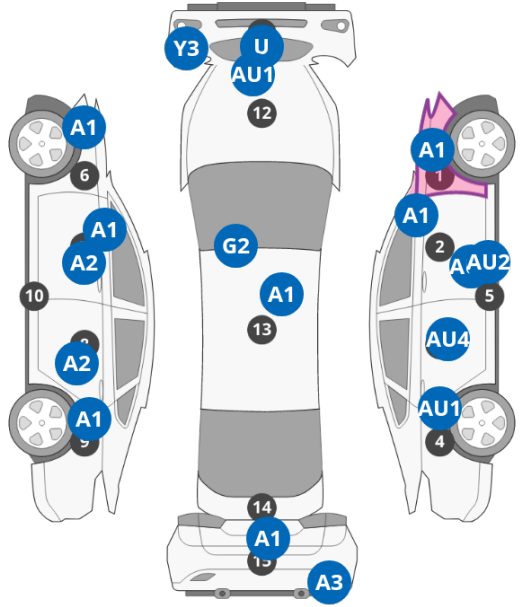
| Interior Evaluation : <b>B</b> | Exterior Evaluation : <b>D</b> |
|---|---|
| <p><b>Remarks</b></p> <p>Ceiling - Grime - Minimal / Rear Seat - Grime - Minimal / Mat Other - Worked - Small / (R) Front Trim - Grime - Small / (R) Front Floor Mat - Grime - Medium / (R) Front Seat - Grime - Small / (L) Front Trim - Grime - Small / (L) Front Floor Mat - Cut, Crack - Small / Carpet - Worked - Minimal</p> | <p><b>Remarks</b></p> <p>(R) Front Fender - Repair Traces - Yes / (R) Front Fender, Molding - Repair mark - Yes / (R) Front Fender, Molding - Scratch - Minimal / (R) Mirror - Scratch - Minimal / (R) Front Door, Molding - Scratch &amp; Dent - Medium / (R) Step, In-panel, Side Spoiler - Scratch &amp; Dent - Small / (R) Rear Door, Molding - Scratch &amp; Dent - Large / (R) Rear Fender, Molding - Scratch &amp; Dent - Minimal / Rear Bumper, Lamps, Panels - Scratch - Medium / Trunk Hood, Rear Gate - Scratch - Minimal / (L) Rear Fender, Molding - Scratch - Minimal / (L) Rear Door, Molding - Scratch - Small / (L) Front Door, Molding - Scratch - Small / (L) Mirror - Scratch - Minimal / (L) Front Fender, Molding - Scratch - Minimal / Roof - Scratch - Minimal / Front Windshield - Scratch, Stone chip - Small / Member (Bolted) - Dent - Yes / Bonnet, Headlight - Scratch &amp; Dent - Minimal / Front Bumper, Grille, Lamps - Crack, Gap - Medium</p> |

| Inspector Notes |
|---|
| With Lto plate, with spare tire and jack, with warranty booklet and tools,,1key, scratches on headlights and taillights, fender light issue, battery weak |
