## General Information

| Make | Nissan | Model | NV350 |
| Registration No. | NDD6773 | Chassis No. | JN1TC2E26Z0010197 |

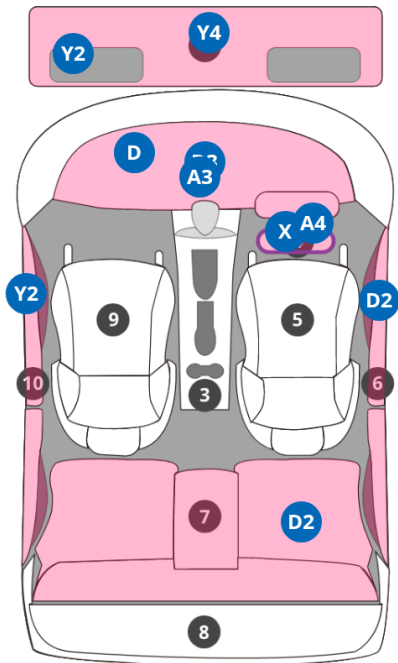
| Interior Evaluation : <b>C</b> | Exterior Evaluation : <b>D</b> |
|---|---|
| <b>Remarks</b><br>Ceiling - Grime - Large / Room Mirror - Missing - Yes / (R) Front Trim - Worked - Small / (L) Front Floor Mat - Missing - Yes / Carpet - Worn, Scratch, Cut, Crack - Large / Dashboard - Loose, Deformed - Medium / Overall Interior - Worn as per age - Yes / (L) Front Trim - Grime - Small / Steering Wheel - Worn, Peel, Crack - Medium / Dashboard - Traces of Adhesive Tape - Yes / Sunvisor, Sunglass Holder - Grime - Small / Trim Other - Worked - Small | <b>Remarks</b><br>(R) Front Door - Repair Traces - Yes / Front Panel - Repair Traces - Yes / (L) Front Door - Repair Traces - Yes / (L) Rear Fender - Repair Traces - Yes / Trunk Hood, Rear Gate - Repair Traces - Yes / (R) Rear Fender - Repair Traces - Yes / (R) Rear Door - Repair Traces - Yes / (R) Center Panel - Repair Traces - Yes / Roof - Repair Traces - Yes / (R) Front Fender, Molding - Scratch - Minimal / (R) Front Door, Molding - Repair mark - Yes / (R) Front Door, Molding - Scratch & Dent - Small / (R) Step, In-panel, Side Spoiler - Scratch - Small / (R) Center Panel - Scratch - Small / (R) Rear Door, Molding - Scratch - Medium / (R) Rear Fender, Molding - Repair mark - Yes / (R) Rear Fender, Molding - Scratch & Dent - Small / Trunk Hood, Rear Gate - Scratch & Dent - Small / Rear Bumper, Lamps, Panels - Scratch - Medium / Roof - Scratch & Dent - Small / (L) Rear Fender, Molding - Scratch & Dent - Small / (L) Front Door, Molding - Scratch & Dent - Minimal / (L) Mirror - Scratch - Minimal / (R) Mirror - Scratch - Small / (L) Front Fender, Molding - Dent - Minimal / Front Panel - Scratch - Minimal / Front Bumper, Grille, Lamps - Scratch - Medium / (L) Step, In-panel, Side Spoiler - Scratch - Minimal |
