## General Information

| Make | Honda | Model | BR-V |
| YOM | 2020 | Odo Meter Reading | 94,332 |
| Registration No. | NFW8406 | Chassis No. | PADDG1810LV301049 |

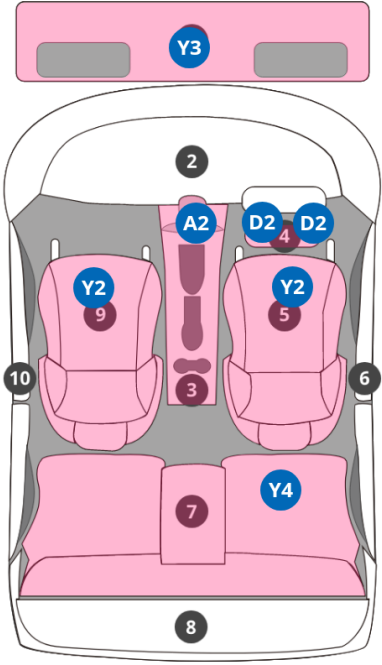
| Interior Evaluation : <span style="color: red;">C</span> | Exterior Evaluation : <span style="color: red;">D</span> |
| <b>Remarks</b><br>Rear Seat - Grime - Large / Ceiling - Grime - Medium / (R) Front Seat - Grime - Small / Console, Switches, Vents - Worn, Scratch, Cut, Crack - Small / (L) Front Seat - Grime - Small / (R) Front Floor Mat - Worked - Small / (L) Front Floor Mat - Worked - Small | <b>Remarks</b><br>(L) Rear Door - Repair Traces - Yes / (R) Front Fender, Molding - Scratch - Minimal / (R) Mirror - Scratch - Minimal / (R) Front Door, Molding - Scratch & Dent - Minimal / (R) Step, In-panel, Side Spoiler - Scratch & Dent - Large / (R) Rear Door, Molding - Scratch & Dent - Minimal / (R) Rear Fender, Molding - Scratch & Dent - Minimal / Rear Bumper, Lamps, Panels - Scratch & Dent - Large / Trunk Hood, Rear Gate - Scratch - Minimal / (L) Rear Fender, Molding - Scratch - Medium / (L) Rear Door, Molding - Scratch & Dent - Minimal / (L) Step, In-panel, Side Spoiler - Scratch & Dent - Small / (L) Front Door, Molding - Scratch - Minimal / (L) Mirror - Scratch - Small / (L) Front Fender, Molding - Scratch - Minimal / Front Bumper, Grille, Lamps - Scratch & Dent - Large / Bonnet, Headlight - Scratch - Minimal / Roof - Scratch - Minimal |

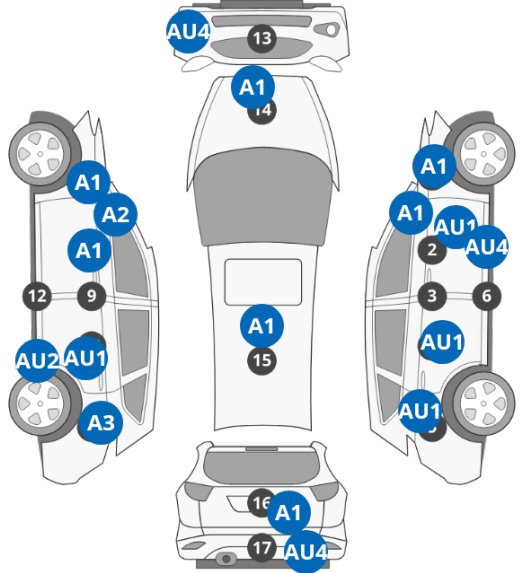
NO Lto plate, with spare tire and jack, 1key, no warranty booklet and tools, faded headlights, scratches on taillights, trunk door issue, Right rear door issue,
