## General Information

| Make | Nissan | Model | Terra |
| Registration No. | NDL6371 | Chassis No. | MNTJCND23Z002026 |

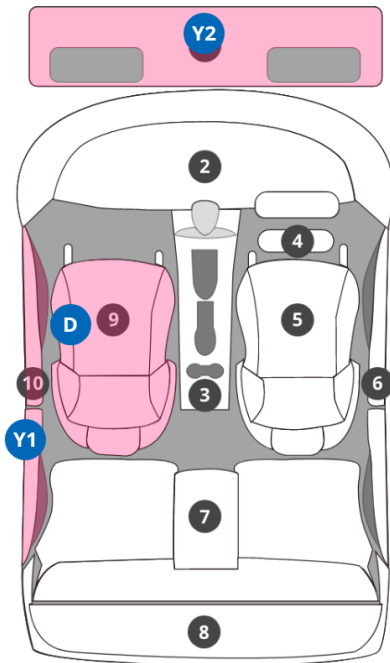
| Interior Evaluation : <b>B</b> | Exterior Evaluation : <b>D</b> |
| <p><b>Remarks</b><br/>Ceiling - Grime - Small / (L) Rear Trim - Grime - Minimal / (L) Front Seat - Worn - Yes</p> | <p><b>Remarks</b><br/>(R) Front Fender, Molding - Scratch &amp; Dent - Small / (R) Mirror - Scratch - Minimal / (R) Front Door, Molding - Scratch &amp; Dent - Minimal / (R) Step, In-panel, Side Spoiler - Scratch - Small / (R) Rear Door, Molding - Scratch - Medium / (R) Rear Fender, Molding - Scratch - Small / Rear Bumper, Lamps, Panels - Scratch - Large / Trunk Hood, Rear Gate - Scratch - Minimal / (L) Rear Fender, Molding - Scratch - Small / (L) Rear Door, Molding - Scratch - Minimal / (L) Front Door, Molding - Scratch &amp; Dent - Minimal / (L) Step, In-panel, Side Spoiler - Scratch - Medium / (L) Mirror - Scratch - Minimal / (L) Front Fender, Molding - Scratch - Minimal / Front Bumper, Grille, Lamps - Scratch - Large / Bonnet, Headlight - Scratch - Minimal / Front Windshield - Scratch, Stone chip - Small</p> |
