## General Information

| Make | Honda | Model | Civic |

## Body / Panel Condition

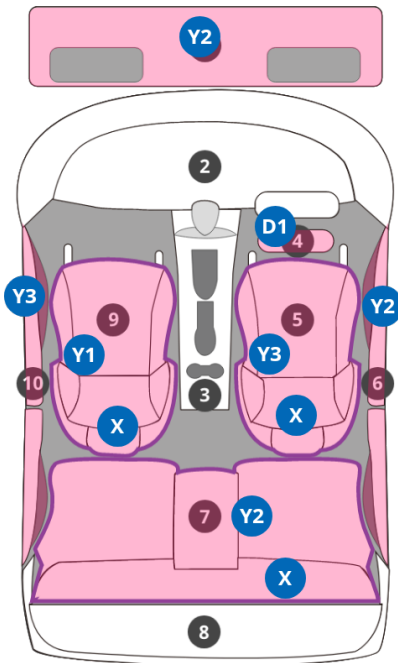
| Interior Evaluation : <b>B</b> | Exterior Evaluation : <b>E</b> |
| <p><b>Remarks</b></p> <p>Ceiling - Grime - Small / (R) Front Seat Head Rest - Missing - Yes / (L) Front Seat Head Rest - Missing - Yes / Rear Seat Head Rest - Missing - Yes / Rear Seat - Grime - Small / (R) Front Trim - Grime - Small / (R) Front Seat - Grime - Medium / Carpet - Worked - Minimal / (L) Front Trim - Grime - Medium / (L) Front Seat - Grime - Minimal</p> | <p><b>Remarks</b></p> <p>(R) Rear Fender - Repair Traces - Yes / (R) Rear Door - Repair Traces - Yes / Roof - Repair Traces - Yes / (R) Front Fender, Molding - Scratch - Medium / (R) Mirror - Crack - Damaged / (R) Front Door, Molding - Scratch &amp; Dent - Medium / (R) Step, In-panel, Side Spoiler - Scratch &amp; Dent - Large / (R) Rear Door, Molding - Scratch &amp; Dent - Minimal / (R) Rear Fender, Molding - Scratch &amp; Dent - Medium / Trunk Hood, Rear Gate - Crack, Gap - Large / Rear Bumper, Lamps, Panels - Scratch &amp; Dent - Large / (L) Rear Fender, Molding - Scratch - Minimal / (L) Rear Door, Molding - Dent - Medium / (L) Front Door, Molding - Scratch &amp; Dent - Large / (L) Step, In-panel, Side Spoiler - Scratch &amp; Dent - Large / (L) Mirror - Crack - Damaged / (L) Front Fender, Molding - Scratch &amp; Dent - Small / Front Bumper, Grille, Lamps - Scratch &amp; Dent - Large / Bonnet, Headlight - Scratch - Minimal / Roof - Scratch - Minimal</p> |
