## General Information

| Make | Nissan | Model | NV350 |
| Registration No. | BAB8122 | Chassis No. | JNTUC4E26Z0025254 |

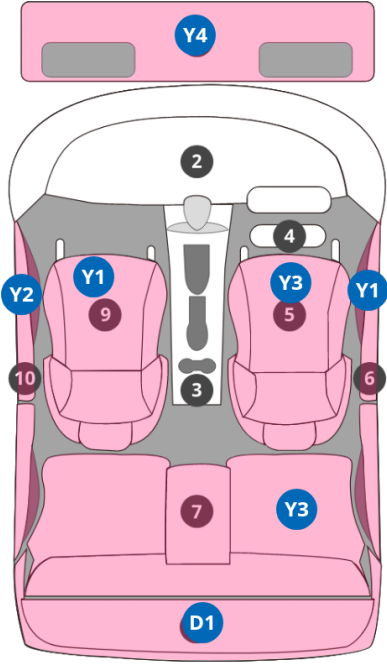
| <b>Interior Evaluation :</b> <span style="color: red; font-weight: bold;">C</span> | <b>Exterior Evaluation :</b> <span style="color: red; font-weight: bold;">E</span> |
| <b>Remarks</b><br>(L) Front Seat - Grime - Minimal / (L) Front Trim - Grime - Small / (R) Front Trim - Grime - Minimal / (R) Front Seat - Grime - Medium / Rear Seat - Grime - Medium / Trunk Room - Loose, Deformed - Minimal / Ceiling - Grime - Large / Overall Interior - Worn as per age - Yes | <b>Remarks</b><br>(R) Rear Fender - Repair Traces - Yes / (R) Rear Door - Repair Traces - Yes / (R) Front Fender, Molding - Scratch - Minimal / (R) Mirror - Scratch - Small / (R) Front Door, Molding - Scratch & Dent - Large / (R) Step, In-panel, Side Spoiler - Scratch & Dent - Medium / (R) Center Panel - Scratch - Medium / (R) Rear Door, Molding - Repair mark - Yes / (R) Rear Door, Molding - Scratch - Large / (R) Rear Fender, Molding - Repair mark - Yes / (R) Rear Fender, Molding - Scratch & Dent - Large / Roof - Scratch & Dent - Medium / Rear Bumper, Lamps, Panels - Scratch & Dent - Large / Trunk Hood, Rear Gate - Scratch & Dent - Medium / (L) Rear Fender, Molding - Scratch & Dent - Large / (L) Front Door, Molding - Scratch & Dent - Medium / (L) Step, In-panel, Side Spoiler - Scratch - Minimal / (L) Mirror - Scratch - Minimal / Front Bumper, Grille, Lamps - Scratch & Dent - Large / Front Panel - Scratch - Minimal / (L) Front Fender, Molding - Scratch & Dent - Minimal |
