## General Information

| Make | Suzuki | Model | Jimny |
| YOM | 2022 | Odo Meter Reading | 35,509 |
| Registration No. | IAE2460 | Chassis No. | MA3JB74V3P0116314 |

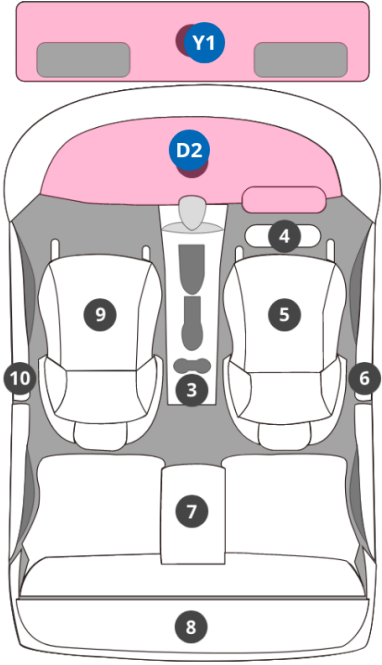
| Interior Evaluation : <span style="color: red; font-weight: bold;">A</span> | Exterior Evaluation : <span style="color: red; font-weight: bold;">B</span> |
|---|---|
| <b>Remarks</b><br>Ceiling - Grime - Minimal / Dashboard - Loose, Deformed - Small | <b>Remarks</b><br>(R) Front Fender, Molding - Scratch - Minimal / (R) Mirror - Scratch - Minimal / (R) Front Door, Molding - Scratch - Minimal / (R) Step, In-panel, Side Spoiler - Scratch - Minimal / (R) Rear Fender, Molding - Scratch - Minimal / Trunk Hood, Rear Gate - Scratch - Minimal / Rear Bumper, Lamps, Panels - Scratch & Dent - Medium / (L) Rear Fender, Molding - Scratch - Minimal / (L) Front Door, Molding - Scratch & Dent - Minimal / (L) Front Fender, Molding - Scratch - Minimal / Front Bumper, Grille, Lamps - Scratch - Minimal / Bonnet, Headlight - Scratch - Minimal / (L) Mirror - Scratch - Minimal / (L) Step, In-panel, Side Spoiler - Scratch - Minimal |
