## General Information

| Make | Nissan | Model | NV350 |
| Registration No. | NCS9250 | Chassis No. | JN1TC2E26Z0063056 |

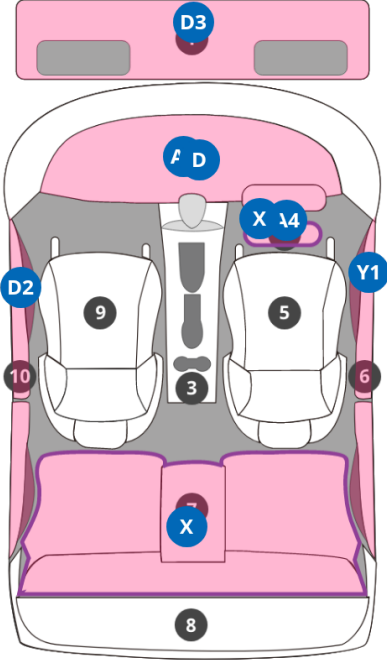
| Interior Evaluation : <b>C</b> | Exterior Evaluation : <b>E</b> |
| <p><b>Remarks</b></p> <p>Rear Seat - Partially Missing - Yes / Carpet - Worn, Scratch, Cut, Crack - Large / (L) Front Floor Mat - Missing - Yes / (R) Front Trim - Grime - Minimal / Ceiling - Loose, Deformed - Medium / (L) Front Trim - Worked - Small / Steering Wheel - Worn, Peel, Crack - Large / Dashboard - Traces of Adhesive Tape - Yes / Overall Interior - Worn as per age - Yes</p> | <p><b>Remarks</b></p> <p>(R) Front Door - Repair Traces - Yes / Front Panel - Repair Traces - Yes / (L) Front Door - Repair Traces - Yes / (L) Rear Fender - Repair Traces - Yes / Trunk Hood, Rear Gate - Repair Traces - Yes / (R) Rear Fender - Repair Traces - Yes / (R) Rear Door - Repair Traces - Yes / (R) Center Panel - Repair Traces - Yes / Roof - Repair Traces - Yes / (R) Front Fender, Molding - Scratch &amp; Dent - Small / (R) Mirror - Crack - Cracks / (R) Mirror - Scratch - Small / (R) Front Door, Molding - Scratch &amp; Dent - Small / (R) Center Panel - Scratch &amp; Dent - Large / (R) Rear Door, Molding - Scratch &amp; Dent - Large / (R) Step, In-panel, Side Spoiler - Scratch &amp; Dent - Large / (R) Rear Door, Molding - Repair mark - Difference in Color / (R) Rear Fender, Molding - Repair mark - Difference in Color / (R) Rear Fender, Molding - Scratch &amp; Dent - Large / Rear Bumper, Lamps, Panels - Scratch &amp; Dent - Large / Trunk Hood, Rear Gate - Scratch &amp; Dent - Large / (L) Rear Fender, Molding - Scratch &amp; Dent - Large / (L) Front Door, Molding - Scratch &amp; Dent - Medium / (L) Mirror - Scratch - Minimal / (L) Front Fender, Molding - Scratch - Minimal / Front Panel - Scratch &amp; Dent - Medium / Front Bumper, Grille, Lamps - Scratch &amp; Dent - Medium / (L) Step, In-panel, Side Spoiler - Scratch - Small / Roof - Scratch - Small</p> |

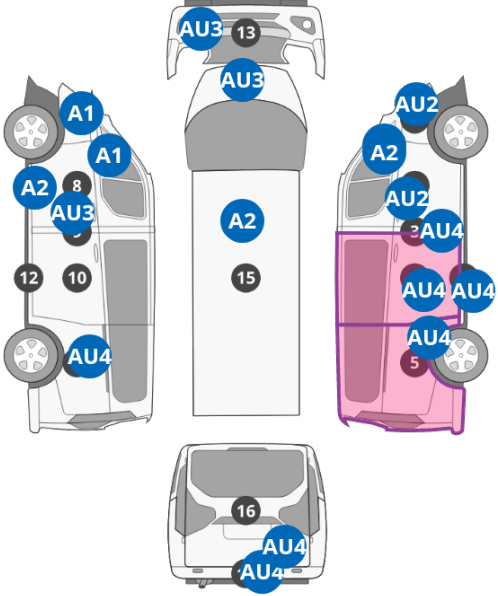
| Inspector Notes |
|---|
| With Lto plate, with spare tire, 1key, no warranty booklet and tools and Jack, scratches on headlights and taillights, non moving vehicle,instrument panel issue,turn signal issue,radio issue ,aircon issue, |
