## General Information

| Make | Toyota | Model | Hilux Tamaraw |
| Registration No. | GBK2397 | Chassis No. | PAHACACA1S6423830 |

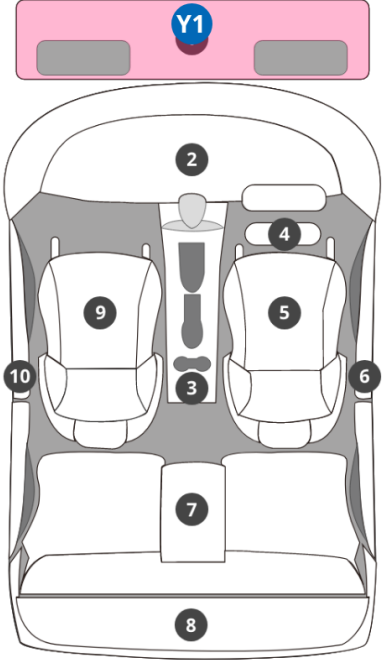
| Interior Evaluation : <b>A</b> | Exterior Evaluation : <b>D</b> |
| <p><b>Remarks</b><br/>Ceiling - Grime - Minimal</p> | <p><b>Remarks</b><br/>Roof - Dent - Large / (R) Front Door, Molding - Scratch - Small / (R) Side Gate - Scratch - Minimal / Rear Gate - Scratch - Large / Cargo Bed Floor - Scratch - Large / (L) Side Gate - Scratch - Minimal / (L) Front Door, Molding - Scratch - Large / Front Bumper, Grille, Lamps - Scratch - Medium</p> |
