## General Information

| Make | Toyota | Model | Lite Ace |

## Body / Panel Condition

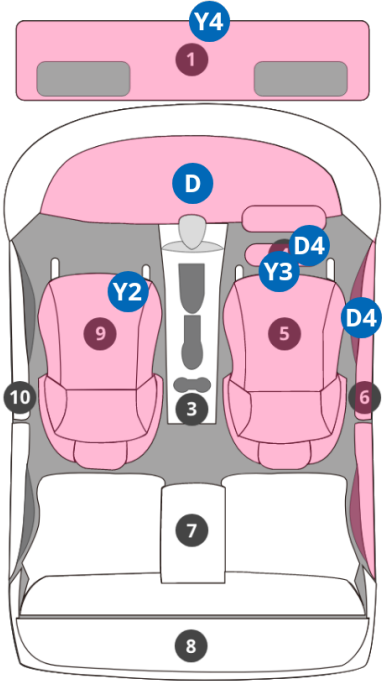
| Interior Evaluation : <span style="color: red; font-weight: bold;">C</span> | Exterior Evaluation : <span style="color: red; font-weight: bold;">E</span> |
| <b>Remarks</b><br>Ceiling - Grime - Large / Carpet - Worked - Large / Dashboard - Traces of Adhesive Tape - Yes / (R) Front Trim - Worked - Large / (R) Front Seat - Grime - Medium / (L) Front Seat - Grime - Small / Overall Interior - Worn as per age - Yes | <b>Remarks</b><br>(L) Rear Corner Panel - Repair Traces - Yes / (R) Front Fender, Molding - Scratch - Small / (R) Front Door, Molding - Scratch - Small / (R) Side Gate - Rust, Corrosion - Large / Rear Gate - Rust, Corrosion - Large / Rear Bumper, Lamps, Panels - Modified - Large / (L) Side Gate - Rust, Corrosion - Large / Cargo Bed Floor - Rust, Corrosion - Large / (L) Front Door, Molding - Scratch & Dent - Small / (L) Front Fender, Molding - Scratch & Dent - Small / Front Panel - Rust, Corrosion - Minimal / Front Bumper, Grille, Lamps - Scratch & Dent - Large |
