## General Information

| Make | Toyota | Model | Vios |

## Body / Panel Condition

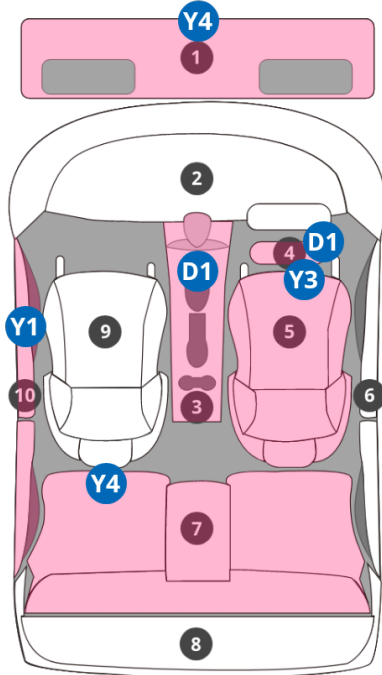
| Interior Evaluation : <b>C</b> | Exterior Evaluation : <b>E</b> |
|---|---|
| <p><b>Remarks</b><br/>Ceiling - Grime - Large / Rear Seat - Grime - Large / (L) Front Trim - Grime - Minimal / (R) Front Seat - Grime - Medium / Carpet - Worked - Minimal / Console, Switchs, Vents - Worked - Minimal</p> | <p><b>Remarks</b><br/>(R) Front Fender, Molding - Scratch &amp; Dent - Large / (R) Front Door, Molding - Scratch - Large / (R) Rear Door, Molding - Scratch - Large / (R) Rear Fender, Molding - Dent - Large / Rear Bumper, Lamps, Panels - Scratch - Large / Trunk Hood, Rear Gate - Scratch - Large / (L) Rear Fender, Molding - Crack, Gap - Small / (L) Rear Door, Molding - Scratch - Minimal / (L) Mirror - Scratch, Peeled - Minimal / Front Bumper, Grille, Lamps - Scratch &amp; Dent - Large / Bonnet, Headlight - Scratch &amp; Dent - Large / Roof - Dent - Small</p> |
