## General Information

| Make | Toyota | Model | Vios |
| YOM | 2025 | Odo Meter Reading | 36,266 |
| Registration No. | FAT3539 | Chassis No. | PA1B18F38S4286668 |

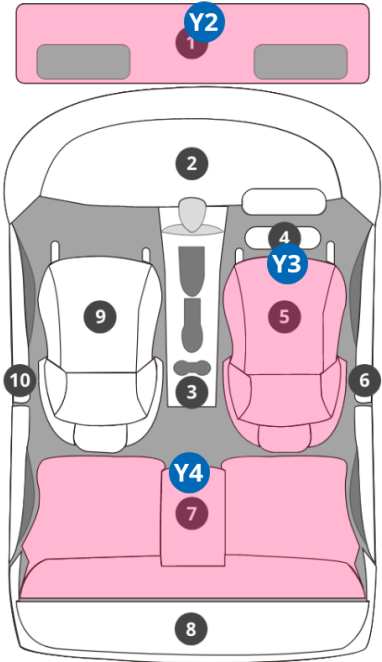
| Interior Evaluation : <span style="color: red;">C</span> | Exterior Evaluation : <span style="color: red;">C</span> |
|---|---|
| <b>Remarks</b><br>(R) Front Seat - Grime - Medium / Ceiling - Grime - Small / Rear Seat - Grime - Large | <b>Remarks</b><br>(R) Front Fender, Molding - Crack, Gap - Small / (R) Mirror - Scratch, Peeled - Minimal / (L) Rear Fender, Molding - Scratch - Medium / (L) Rear Door, Molding - Scratch - Small / (L) Front Door, Molding - Scratch & Dent - Medium / (L) Front Fender, Molding - Scratch - Small / Front Bumper, Grille, Lamps - Scratch - Medium / (R) Rear Fender, Molding - Dent - Medium / (L) Mirror - Stuck - Yes |

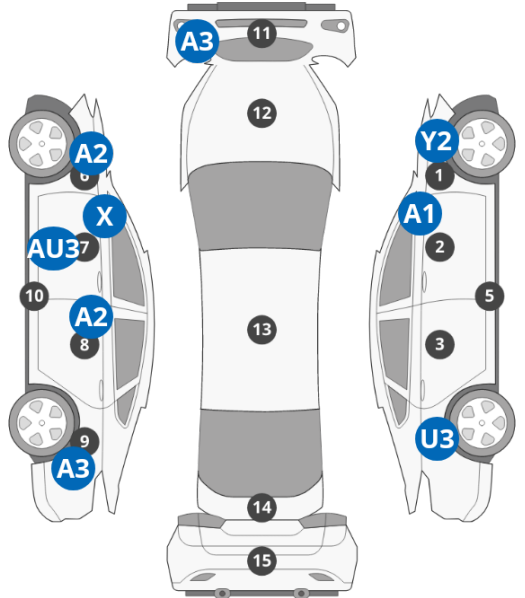
with Ito plates, no warranty booklet, with spare tire, jack and tools, with hairline scratches in the body, starter issue, left side mirror issue
