## General Information

| Make | Toyota | Model | Vios |
| YOM | 2024 | Mileage | 11,904 |

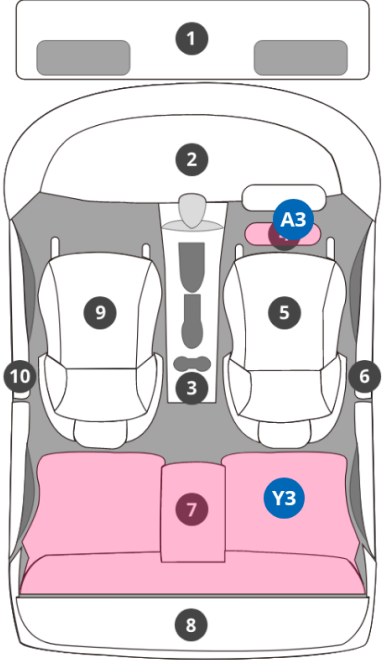
| Interior Evaluation : <b>B</b> | Exterior Evaluation : <b>C</b> |
|---|---|
| <p><b>Remarks</b><br/>Rear Seat - Grime - Medium / (L) Front Floor Mat - Cut, Crack - Medium</p> | <p><b>Remarks</b><br/>(R) Rear Door, Molding - Scratch &amp; Dent - Large / (R) Step, In-panel, Side Spoiler - Scratch - Small / (R) Front Door, Molding - Scratch - Small / (R) Front Fender, Molding - Scratch &amp; Dent - Medium / Front Bumper, Grille, Lamps - Scratch - Large / (L) Front Fender, Molding - Scratch - Small / Rear Bumper, Lamps, Panels - Scratch - Small / (R) Rear Fender, Molding - Dent - Minimal / Roof Spoiler, Molding - Scratch - Minimal / Bonnet, Headlight - Scratch - Small / (L) Rear Door, Molding - Scratch - Small</p> |
